EASTERN MIDDLE SCHOOL FEASIBILITY STUDY

Community Engagement Meeting No. 1

March 4, 2025, 7:00pm

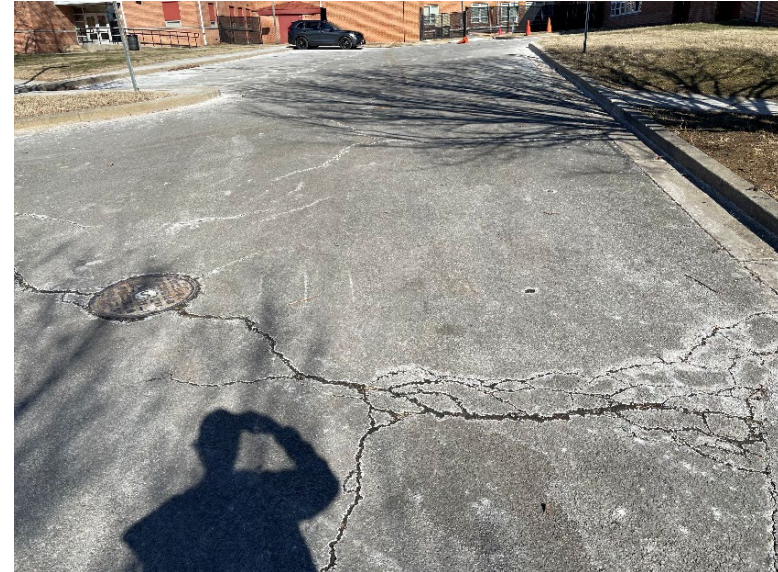
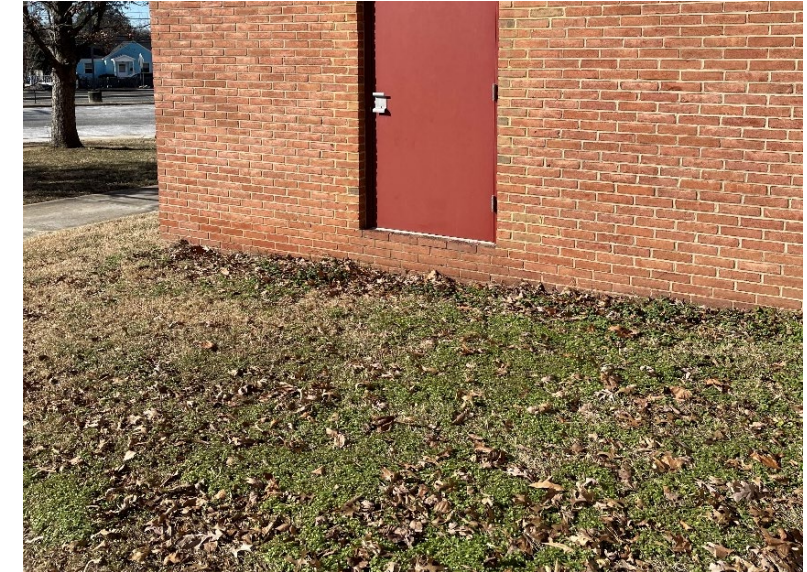
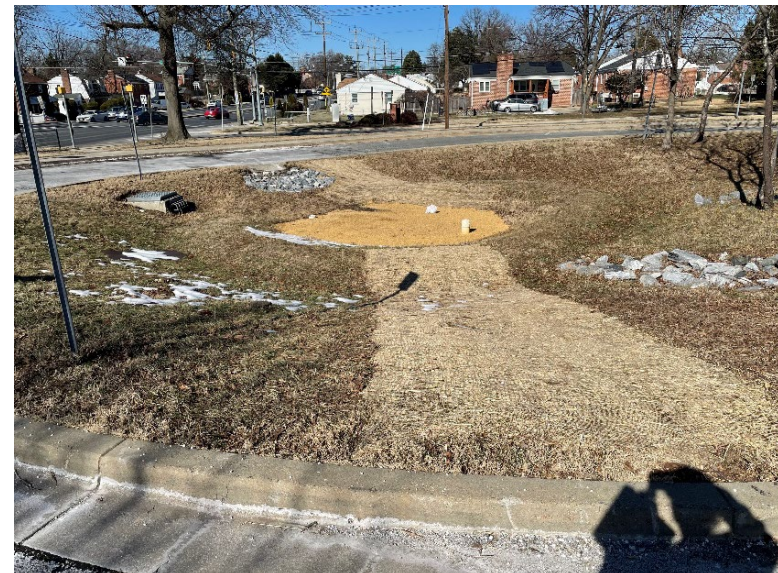
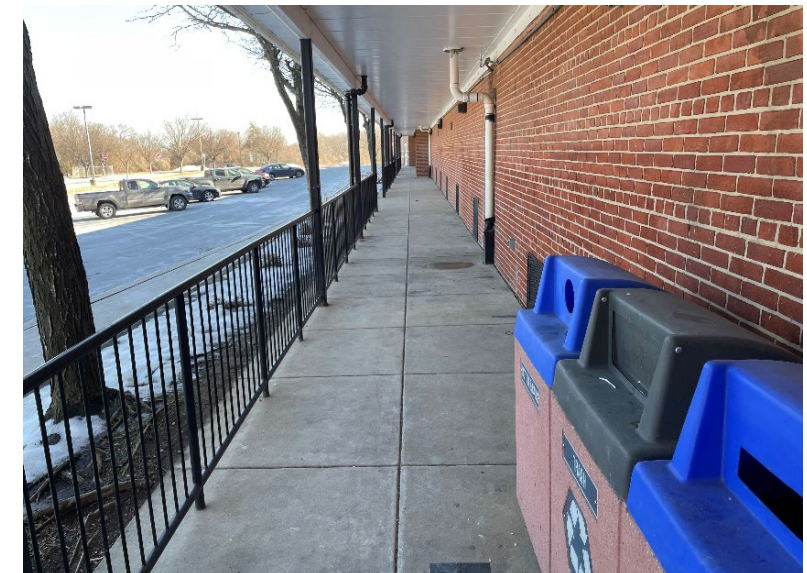
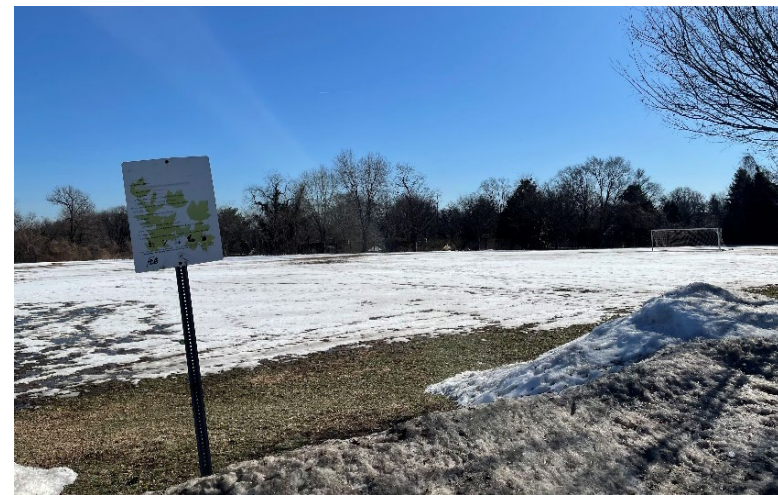
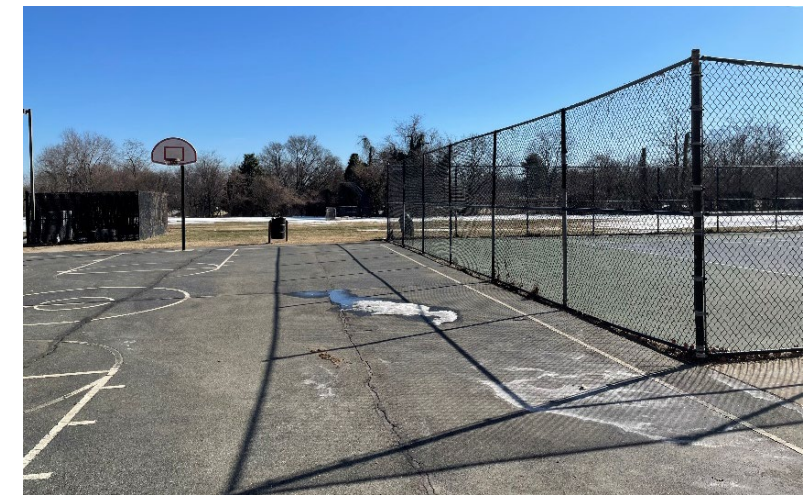
Civil Engineering Observations

- Minor asphalt fatigue noticed throughout much of the site
- ADA parking areas and access to some exterior doors is non-compliant
- One surface sand filter and two subsurface infiltration trenches. Sand filter appears in good condition
- Basketball courts in fair to poor shape. Tennis courts in moderate shape
- Sidewalk generally in good condition
- Surface evidence of water, sanitary, storm, and gas
- Runoff from grass play fields and southwestern tennis/basketball courts drain towards adjacent residential properties

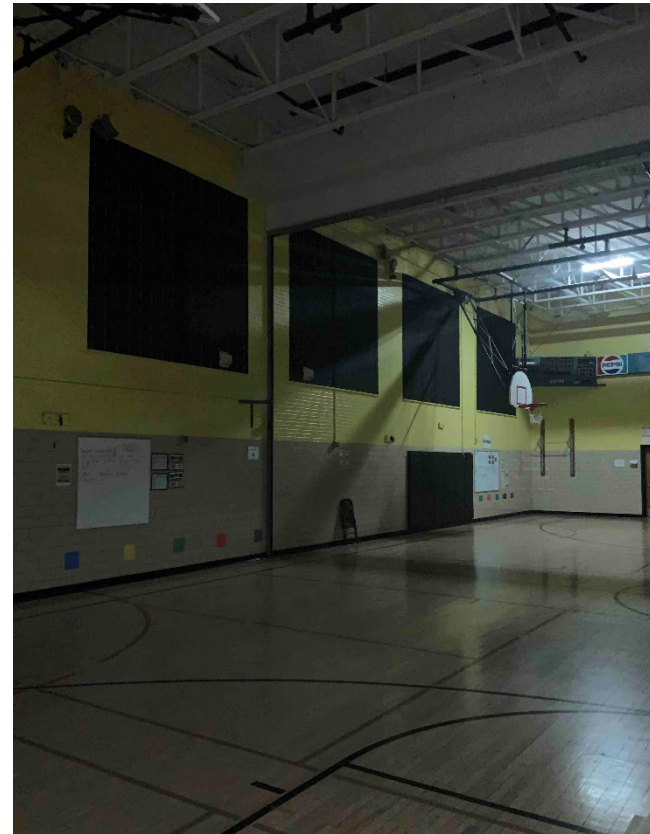
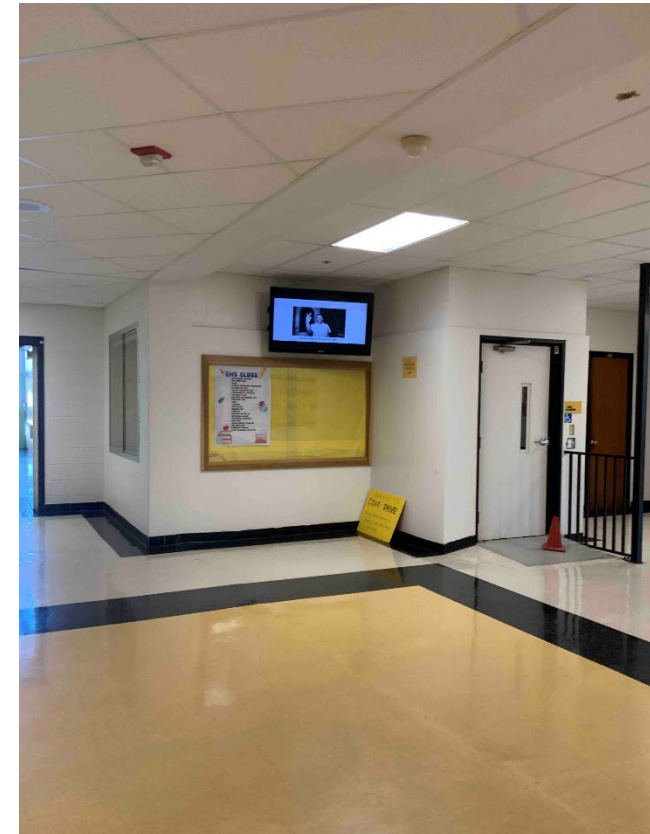
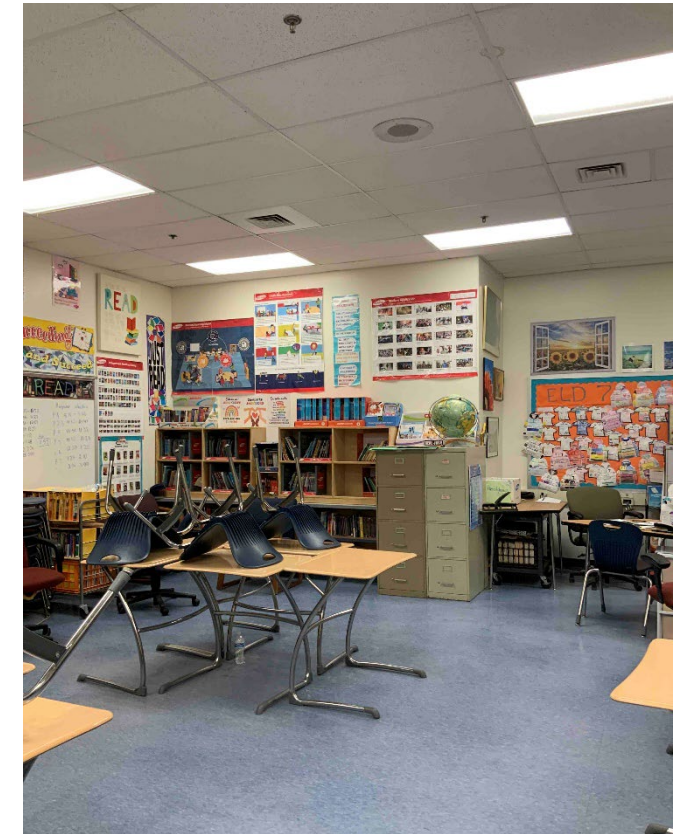
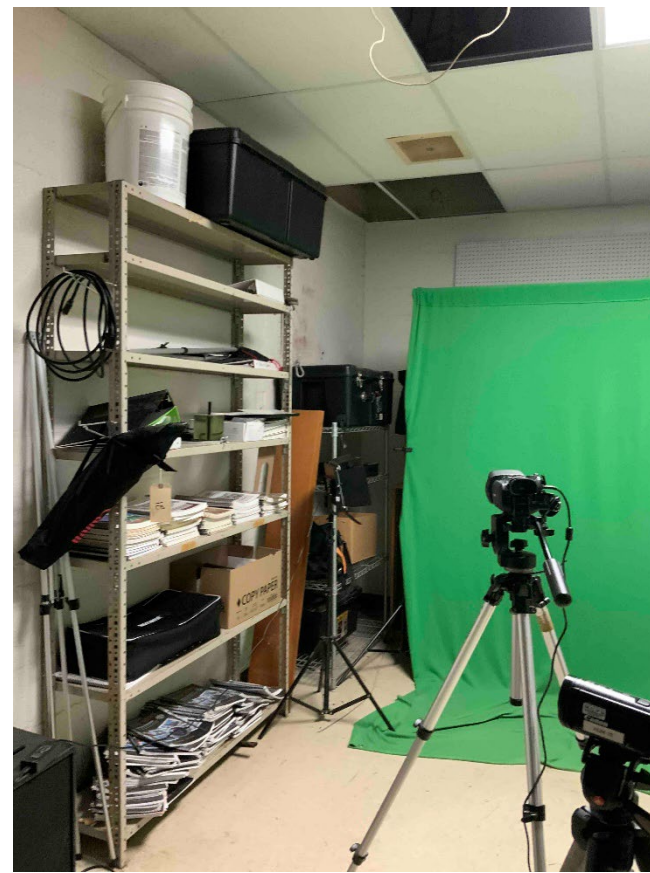
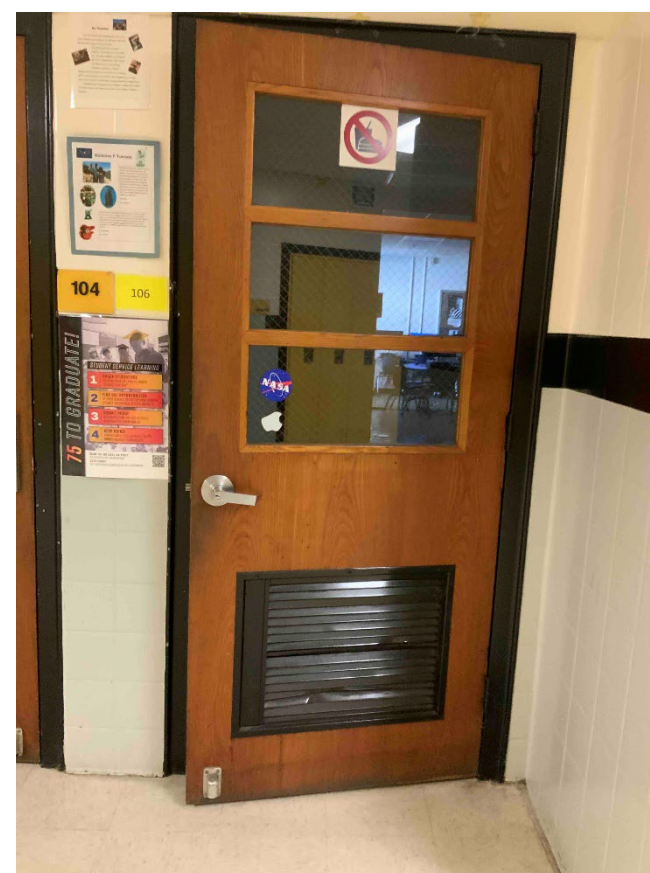
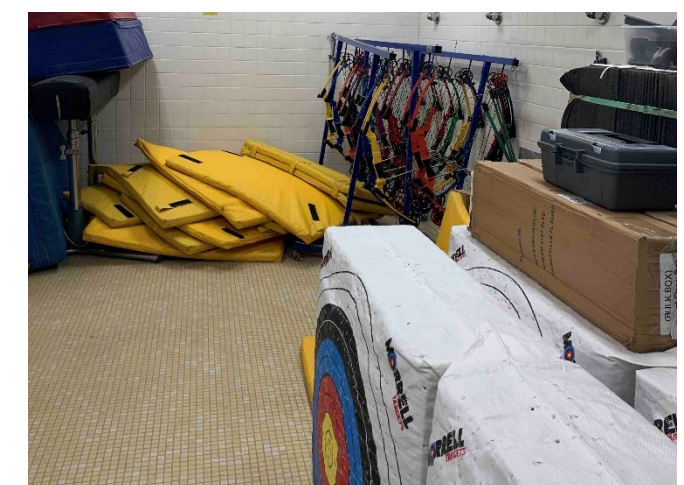
Architectural Observations – 1951 Building

- ADA accessibility issues
- Limited daylighting and exterior views in teaching spaces
- Acoustic concerns
- Inadequate storage and finishes for PE program
- Lack of program space for Magnet program
- Lack of exterior insulation
- Lack of breakout spaces
- Institutional corridors

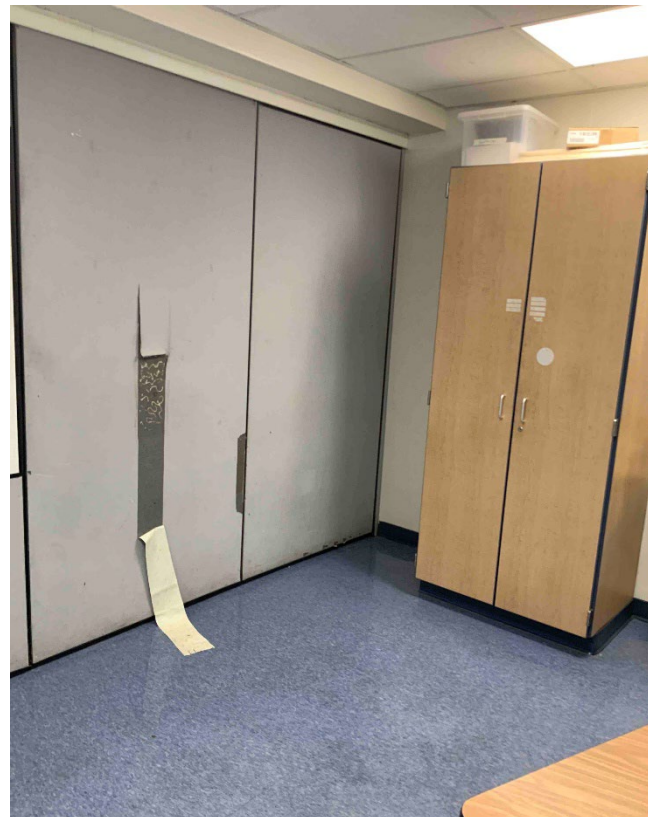
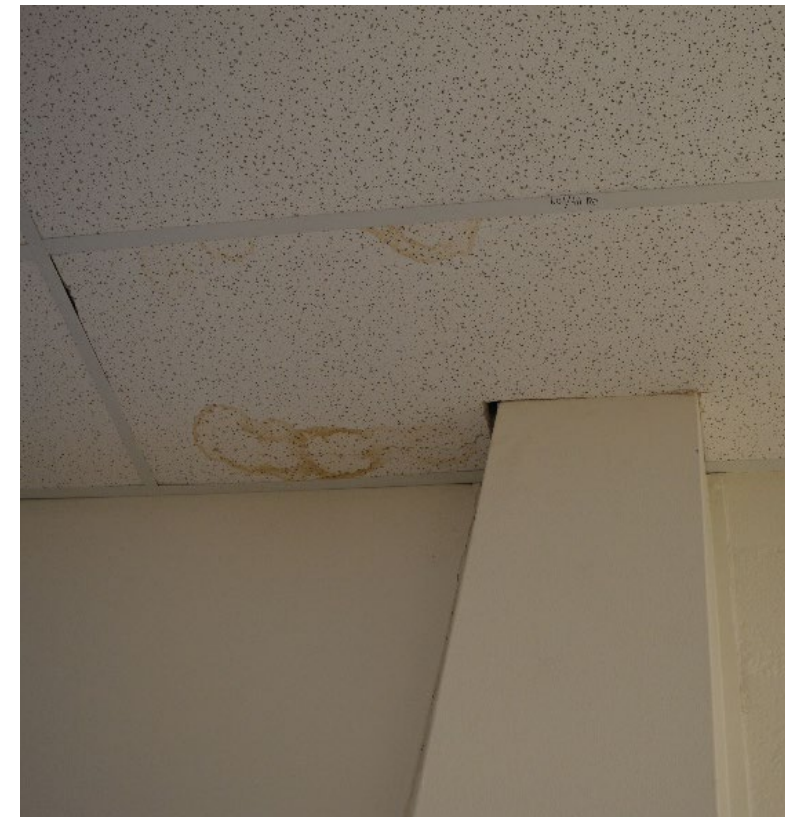
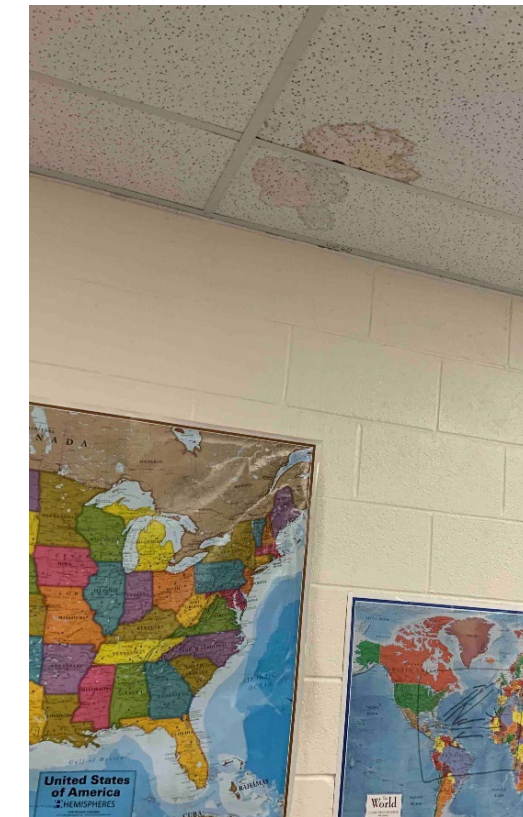
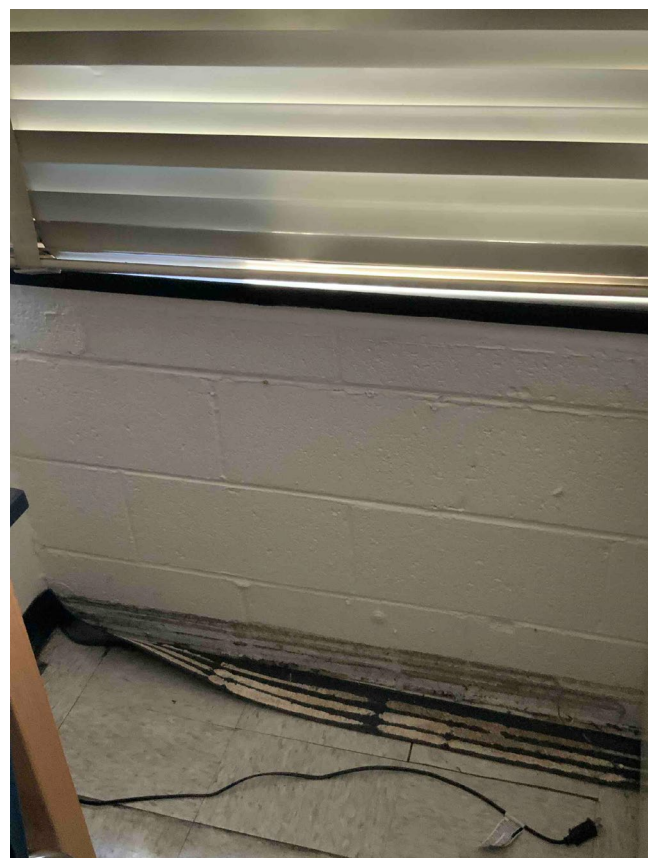
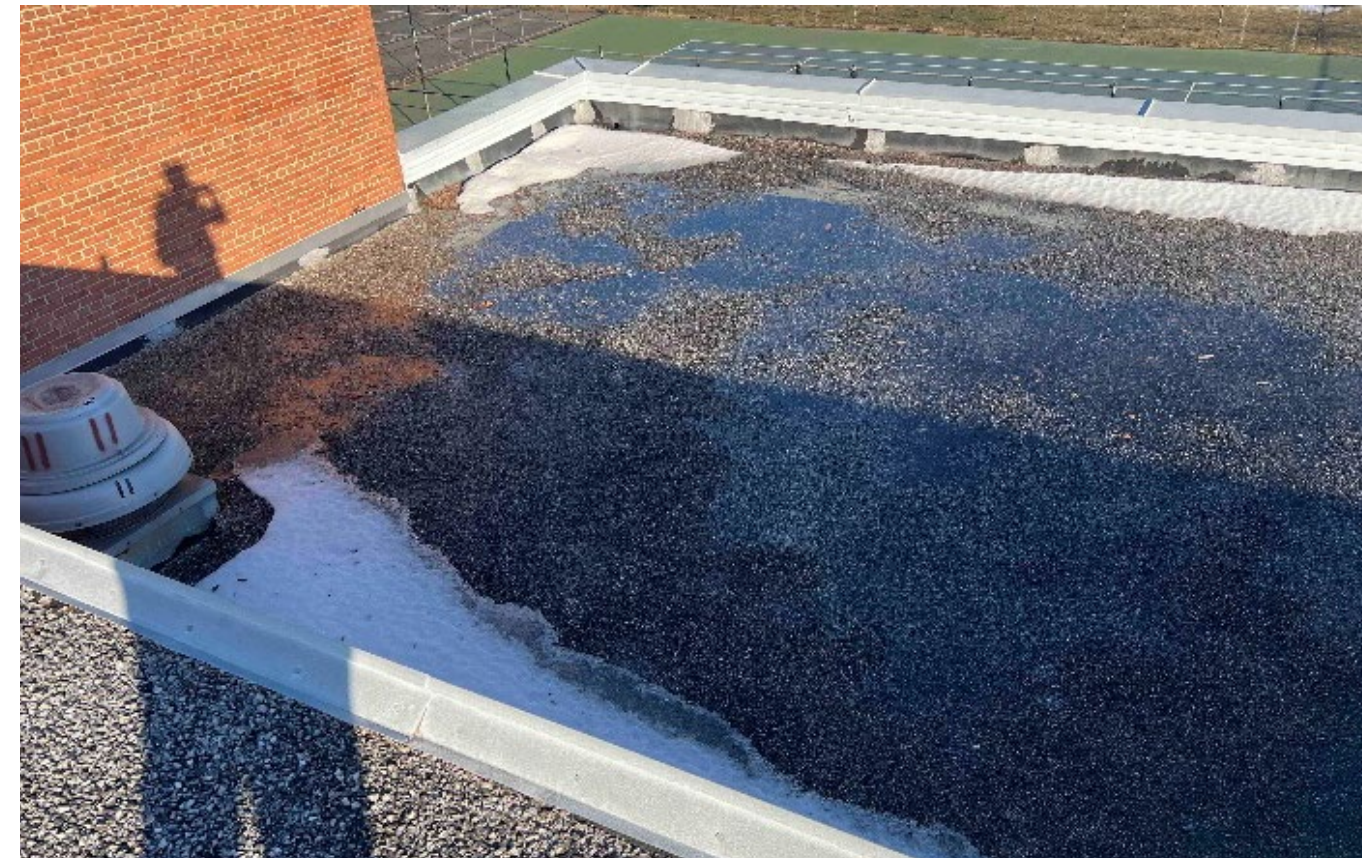
Architectural Observations – 1956 Addition

- Deteriorating classroom finishes
- Visible ceiling leaks
- Signs of water infiltration
- Water ponding on roof

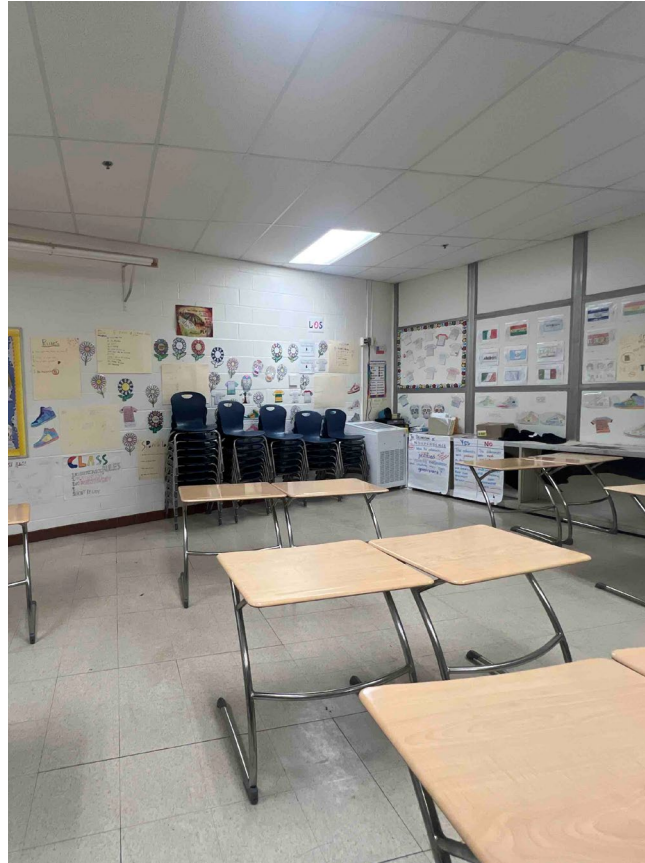
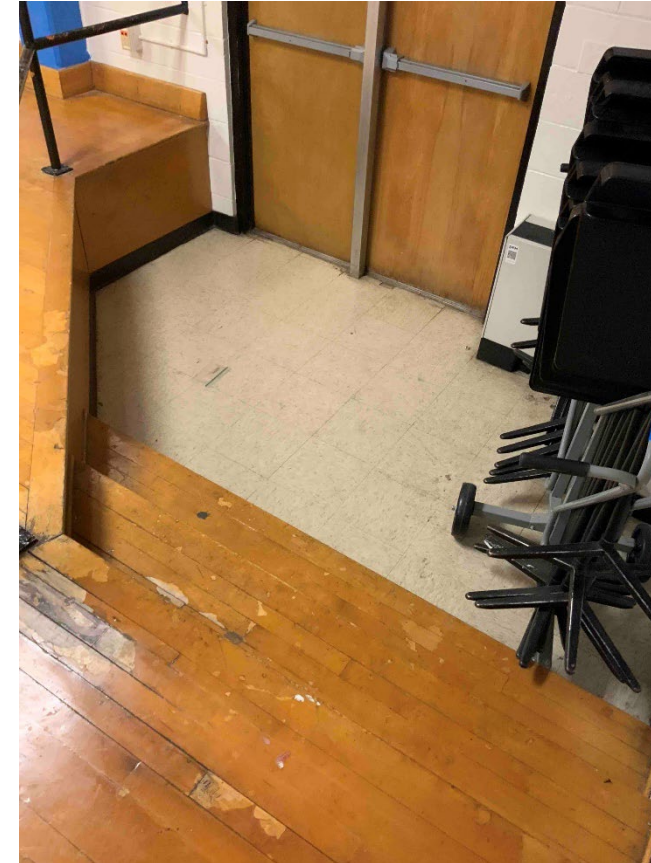
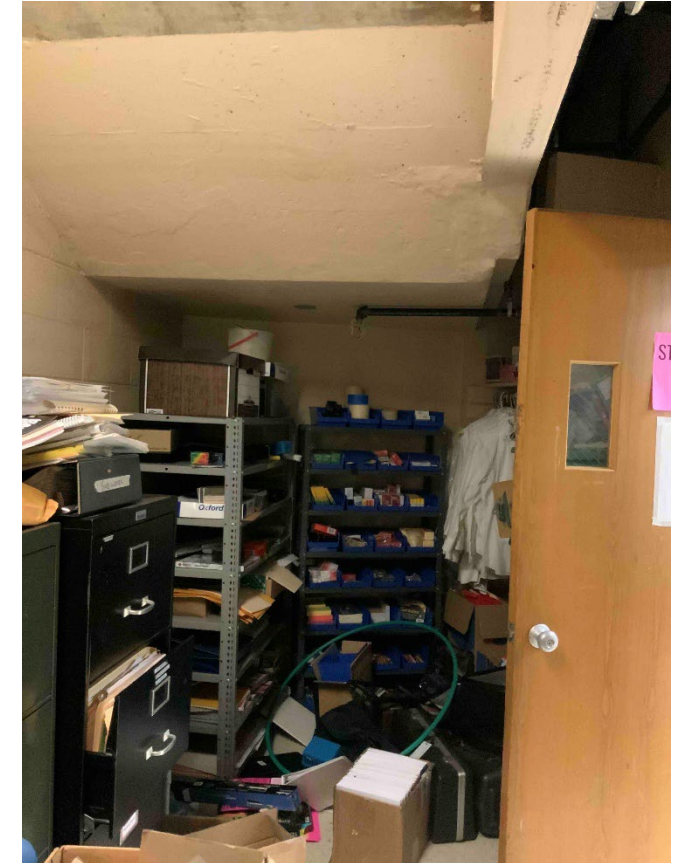
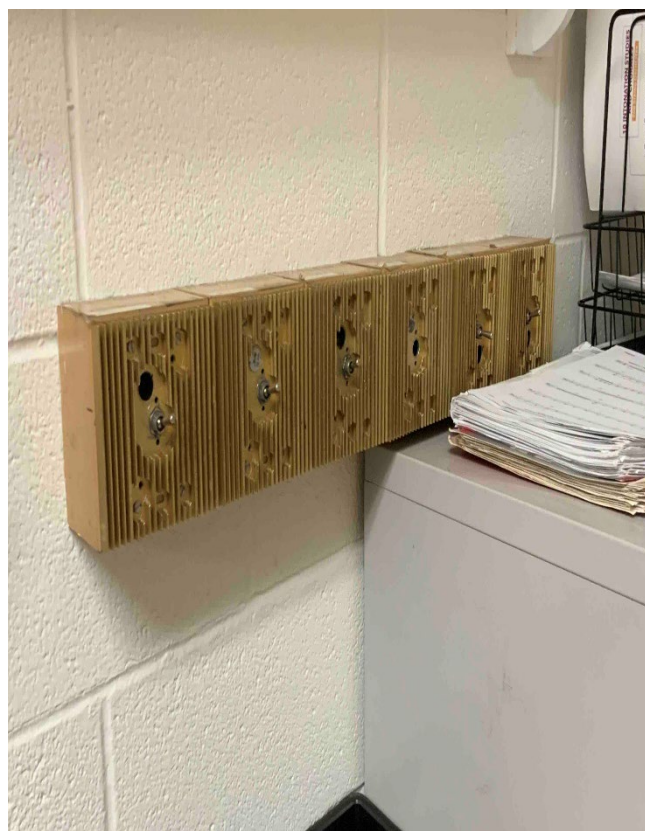
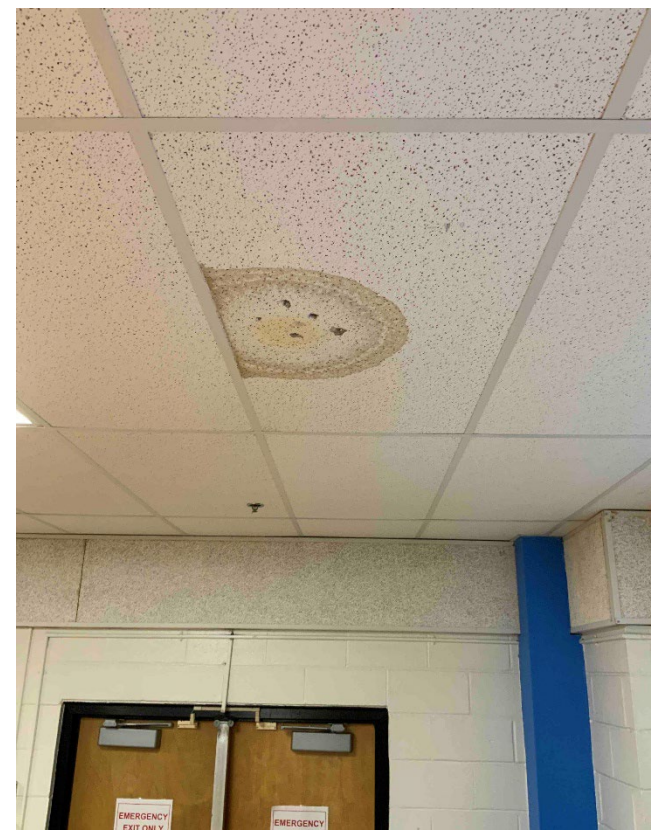
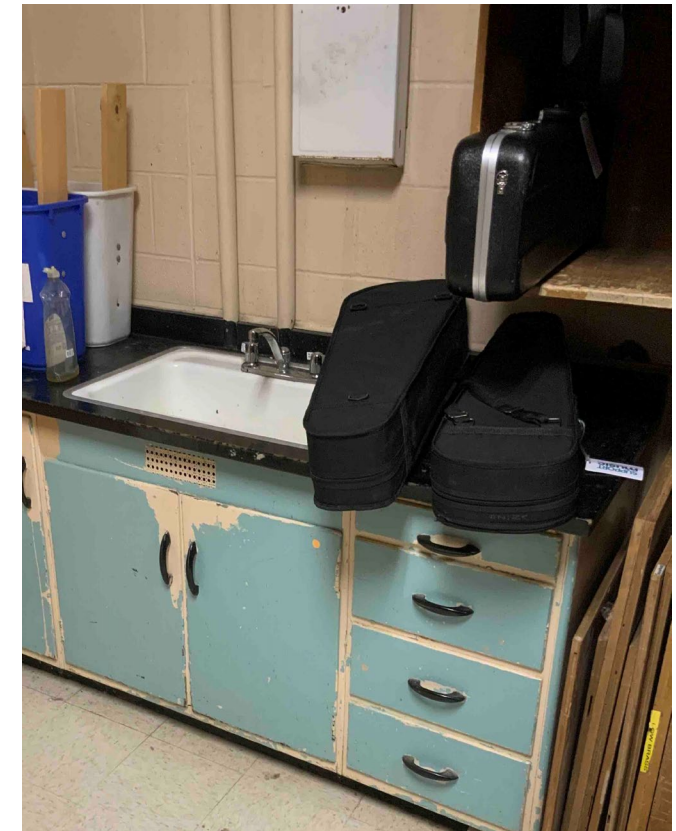
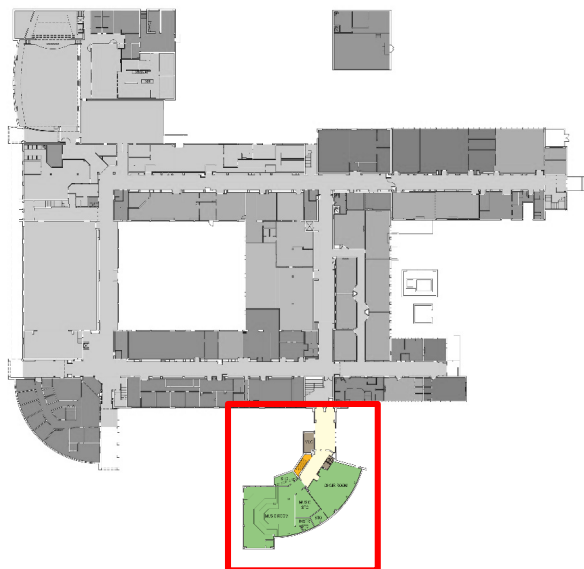
Architectural Observations – 1962 Addition

- No access to daylight
- Accessibility concerns
- Inadequate storage
- Outdated systems
- Casework in poor condition
- Signs of water infiltration

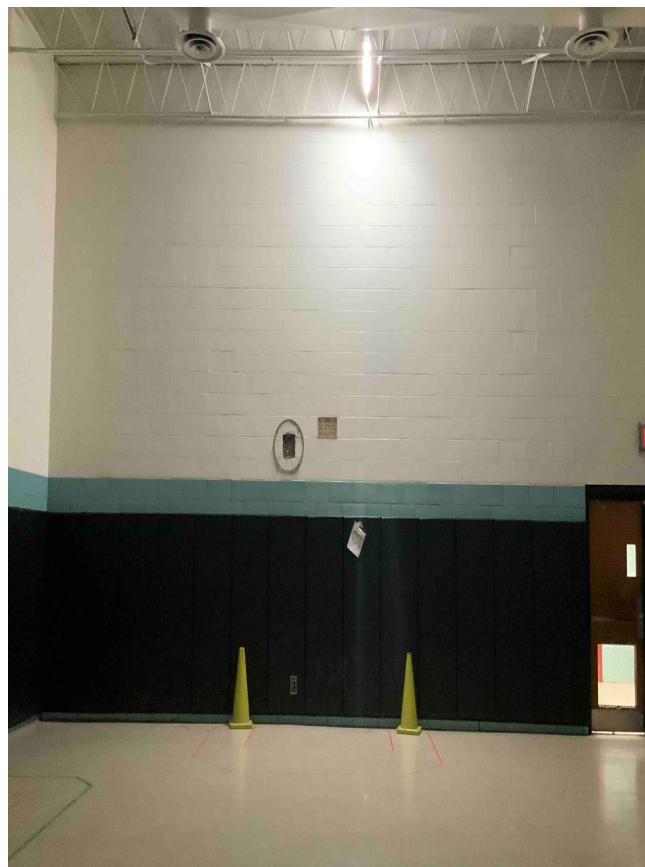
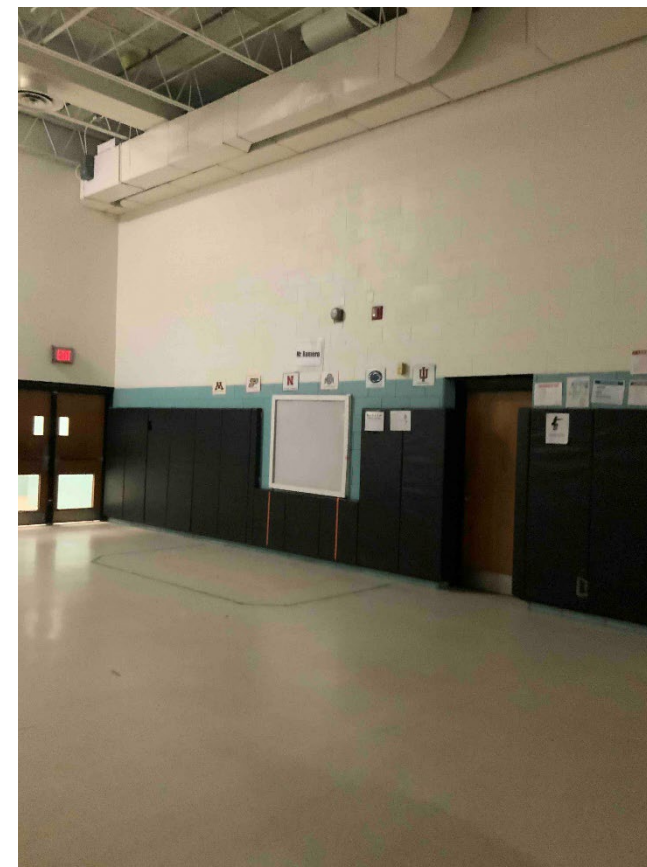
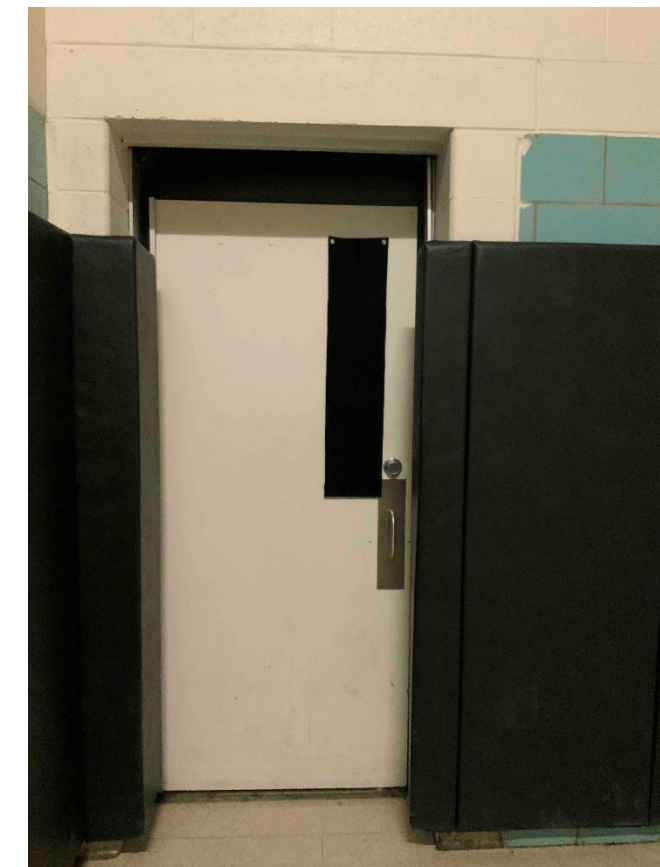
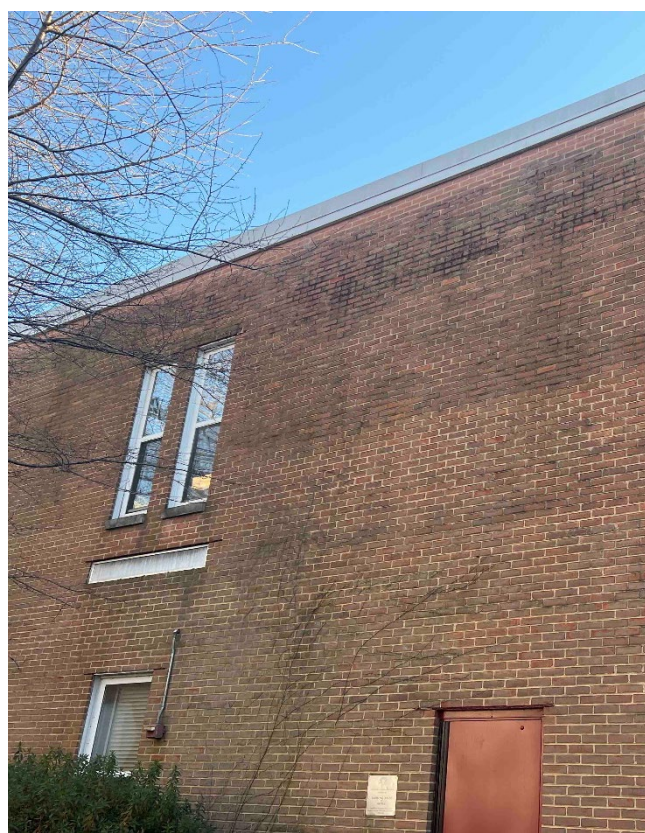
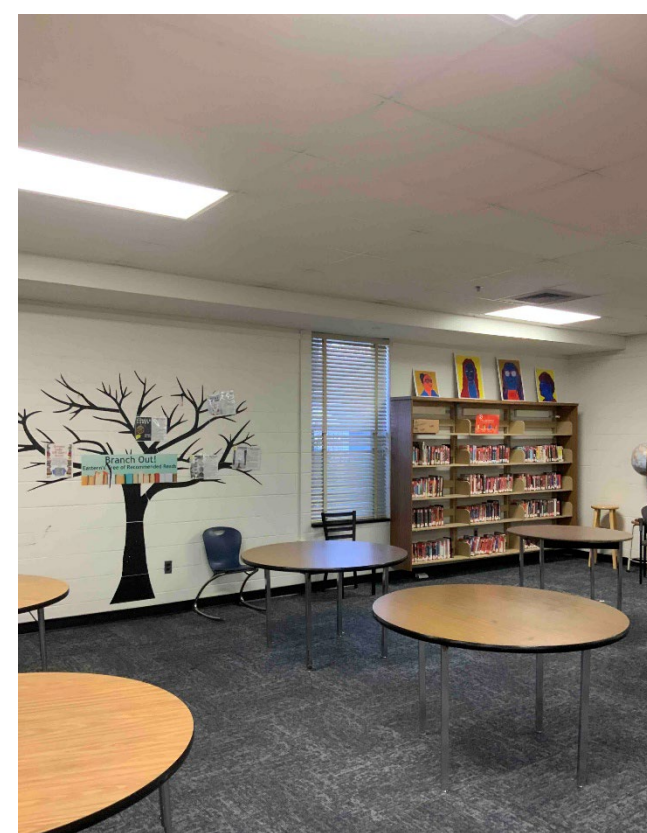
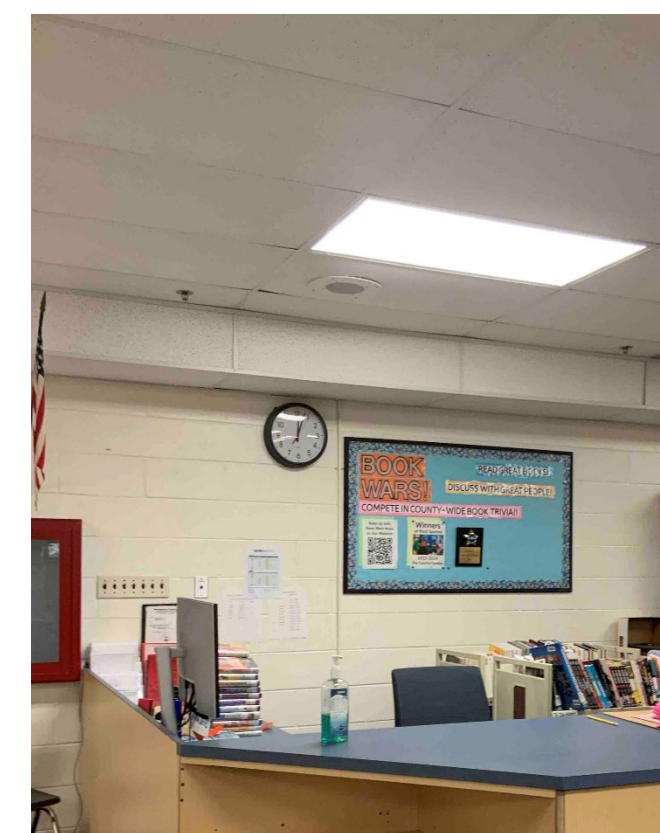
Architectural Observations – 1974 Addition & Renovation

- No daylighting in Aux Gym
- Minimal daylighting in Media Center
- Signs of moisture above ceiling
- Secluded Media Center
- Signs of water infiltration

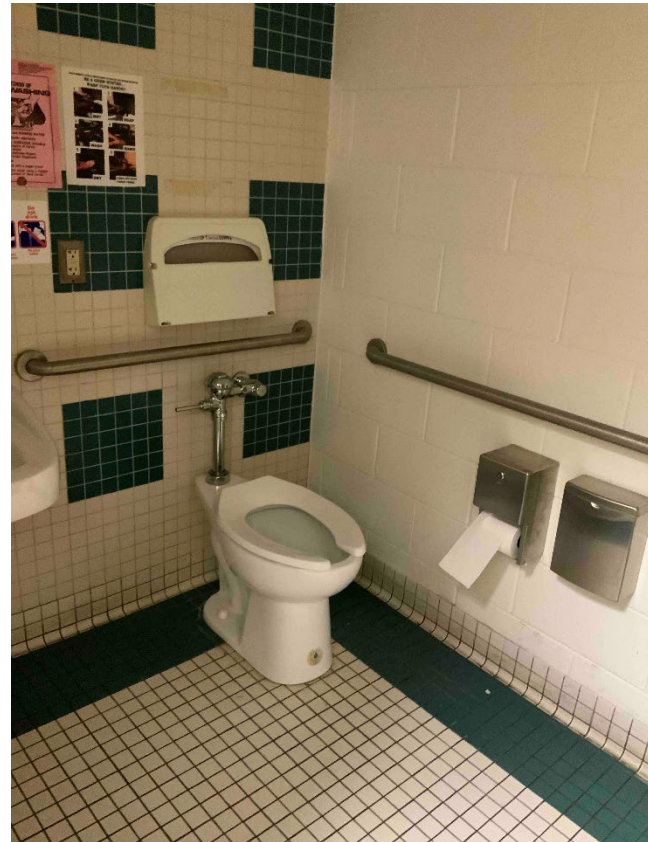
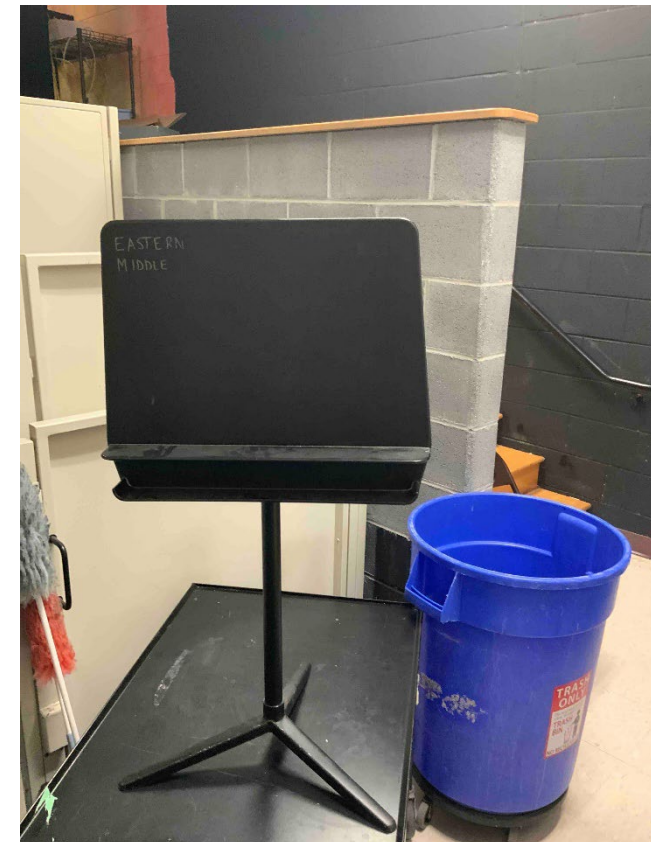
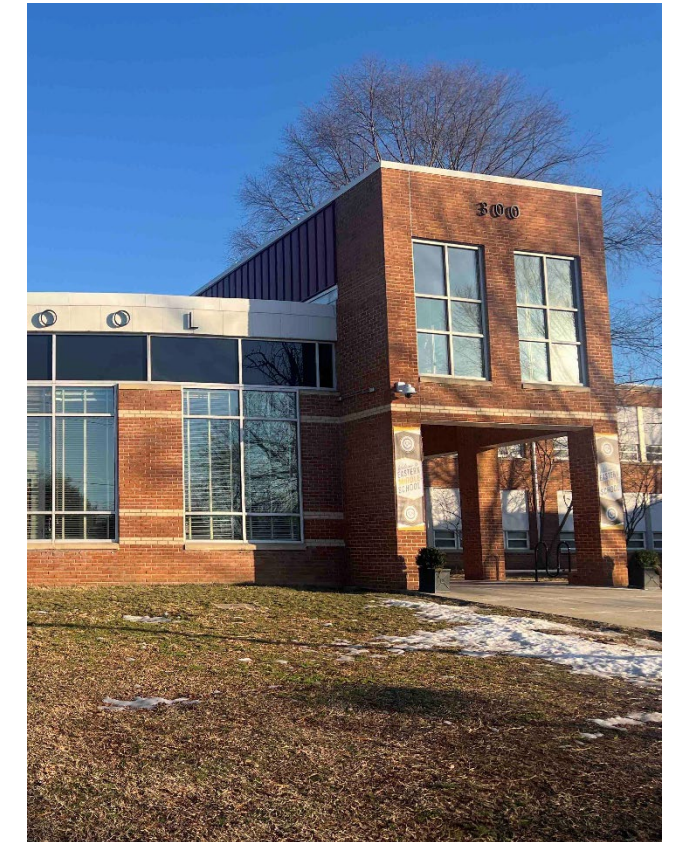
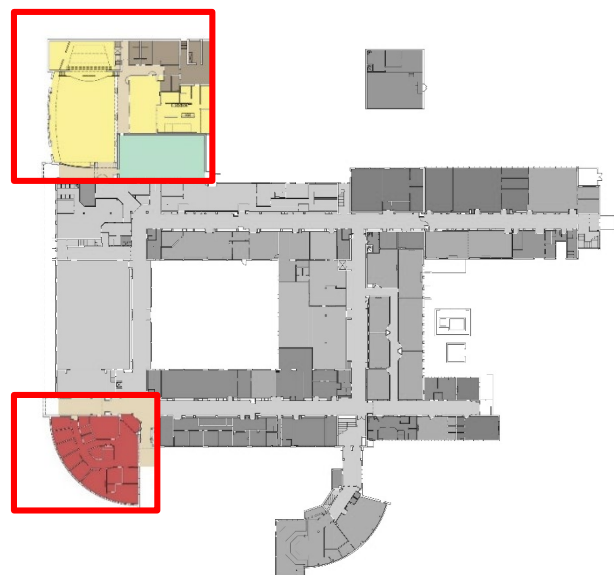
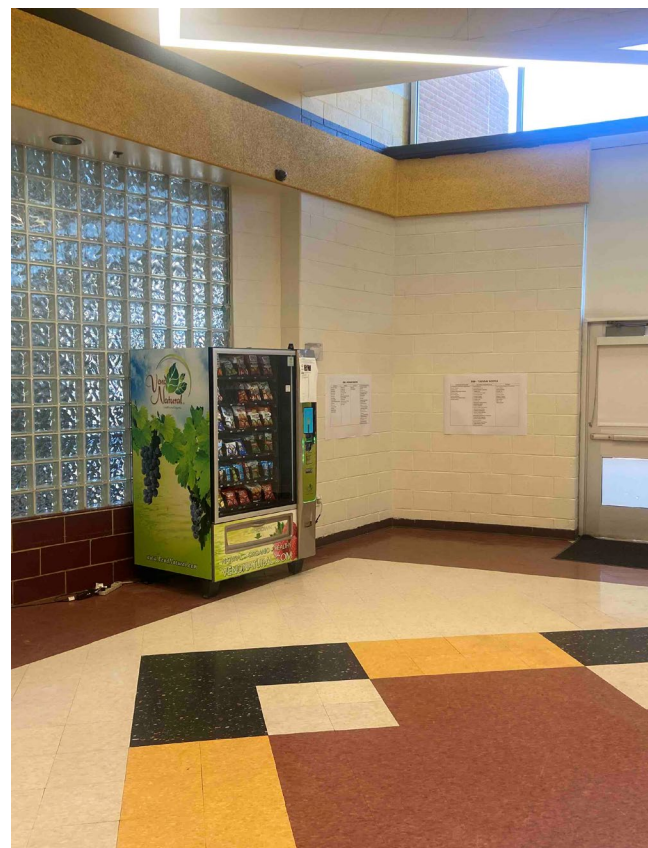
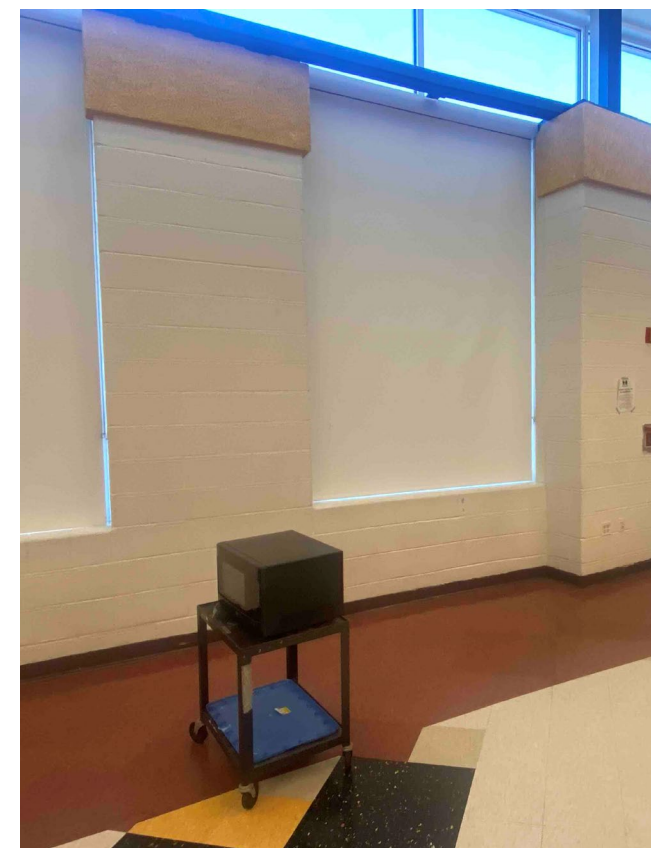
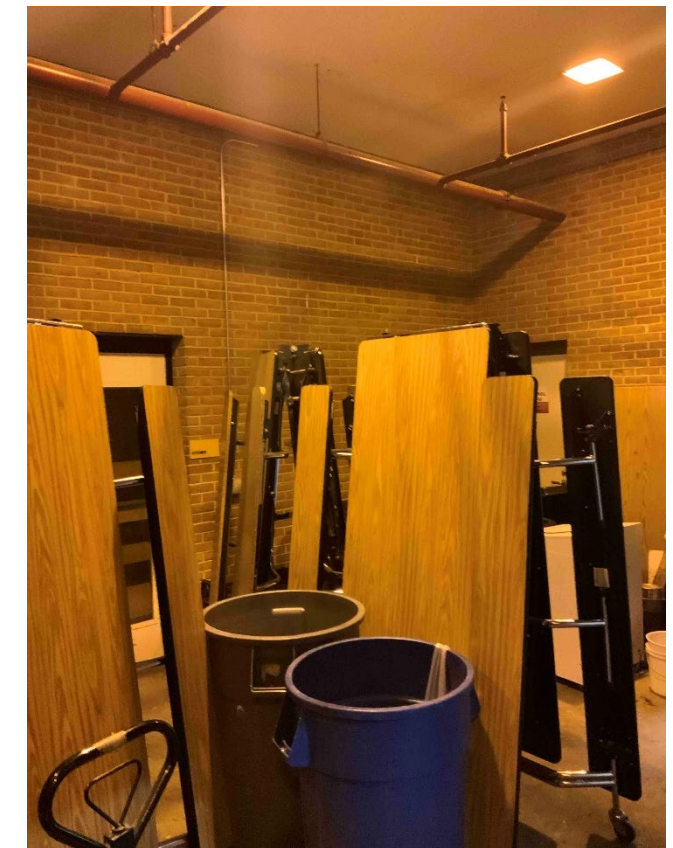
Architectural Observations – 2002 Addition and Renovation

- Inadequate storage
- Has access to plenty of daylight
- Easy access to play areas
- Multiple entrances, primary entrance not prominent
- Signs of water infiltration

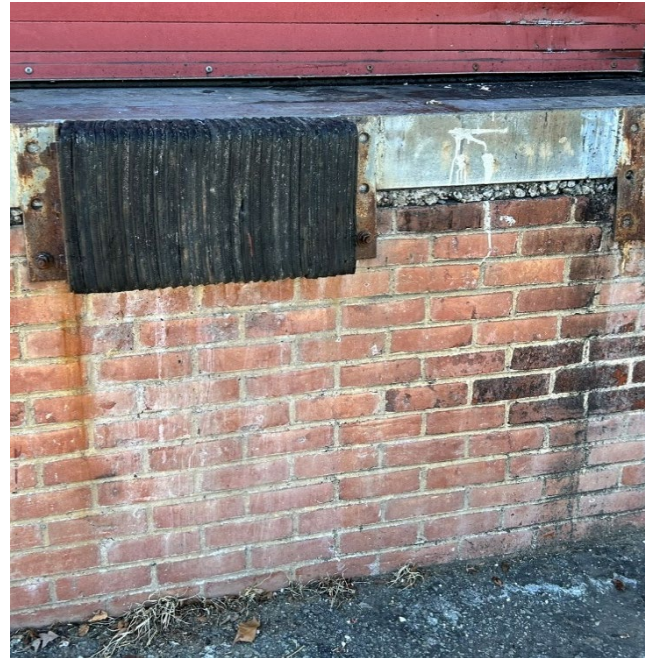
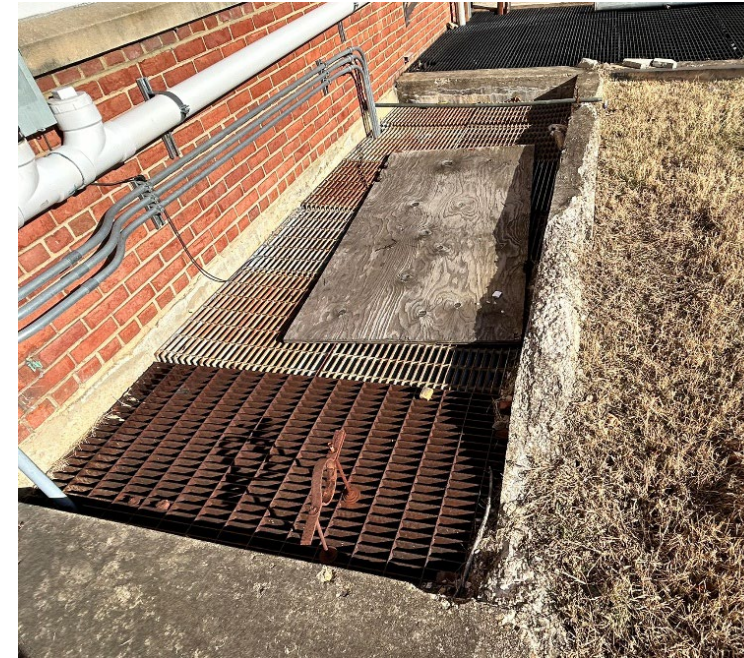
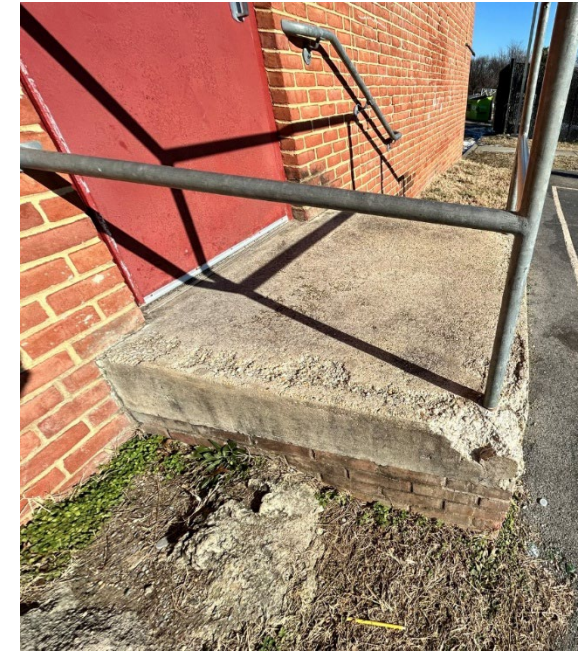
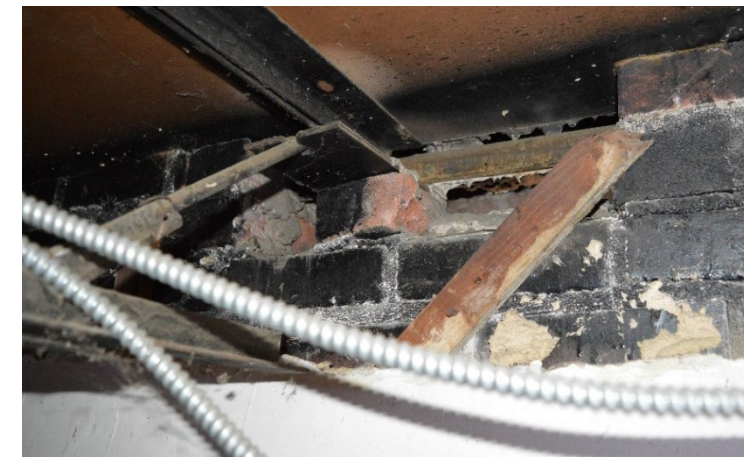
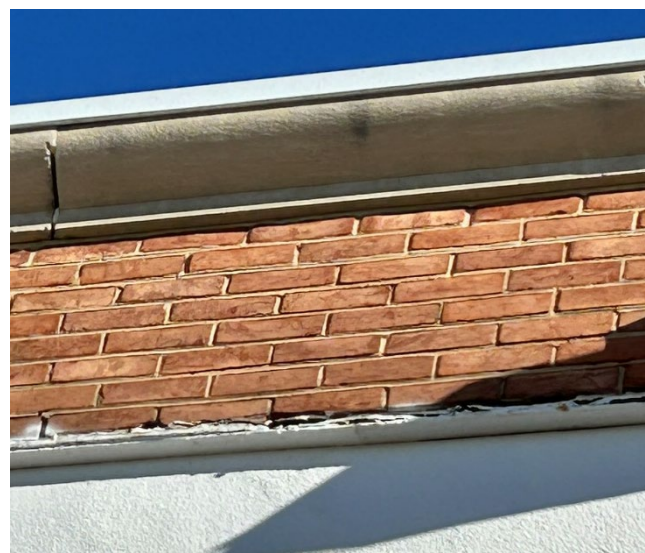
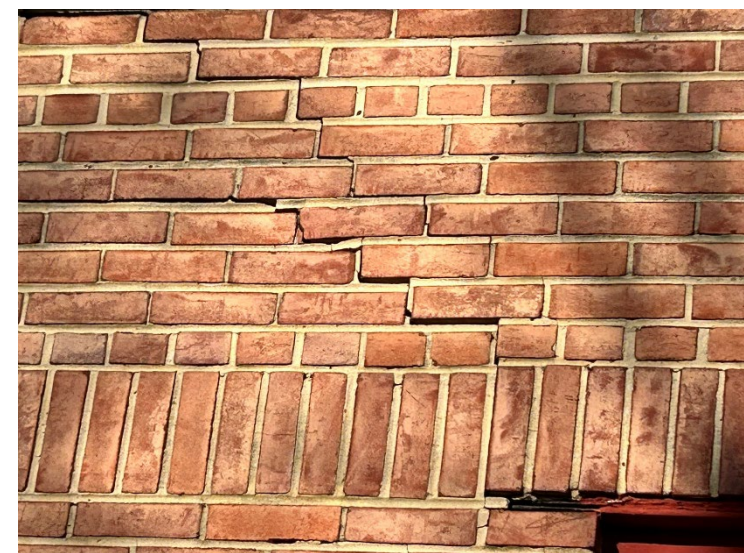
Structural Observations

- Deterioration of the continuous steel bent plate supporting brick
- Stair stepping cracks in brick
- Displacement of brick
- Deterioration of Concrete Areaway
- Significant Displacement and Damage to the exterior sill / masonry wall
- Deterioration of Masonry at Loading Dock

- Evidence of water infiltration along exterior walls
- First floor concrete framing over crawl space inhibits ability to reorganize corridors
- Second floor slab on form deck inhibits ability to reorganize corridors
- Limited data available on foundations of 1951 building
