EASTERN MIDDLE SCHOOL FEASIBILITY STUDY

Community Engagement Meeting No. 1

March 4, 2025, 7:00pm

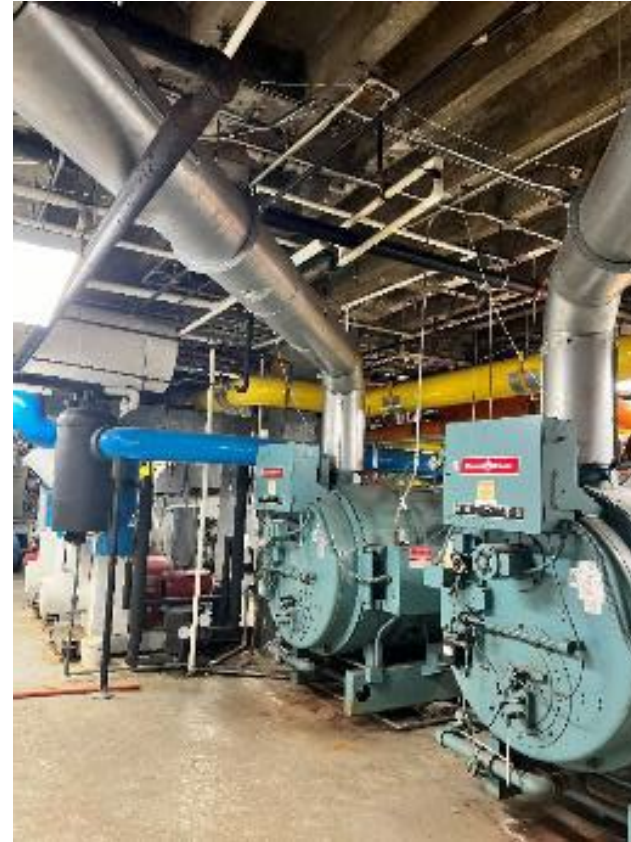
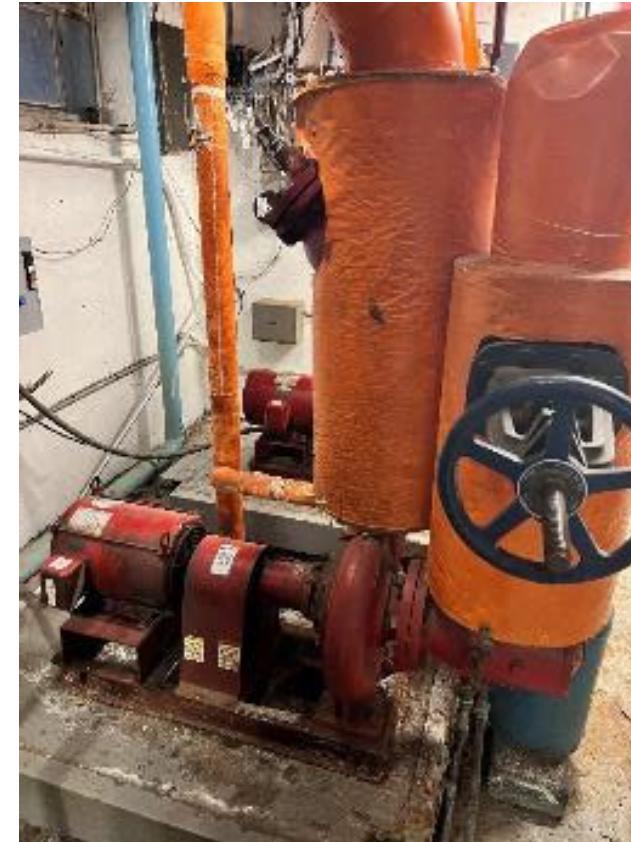
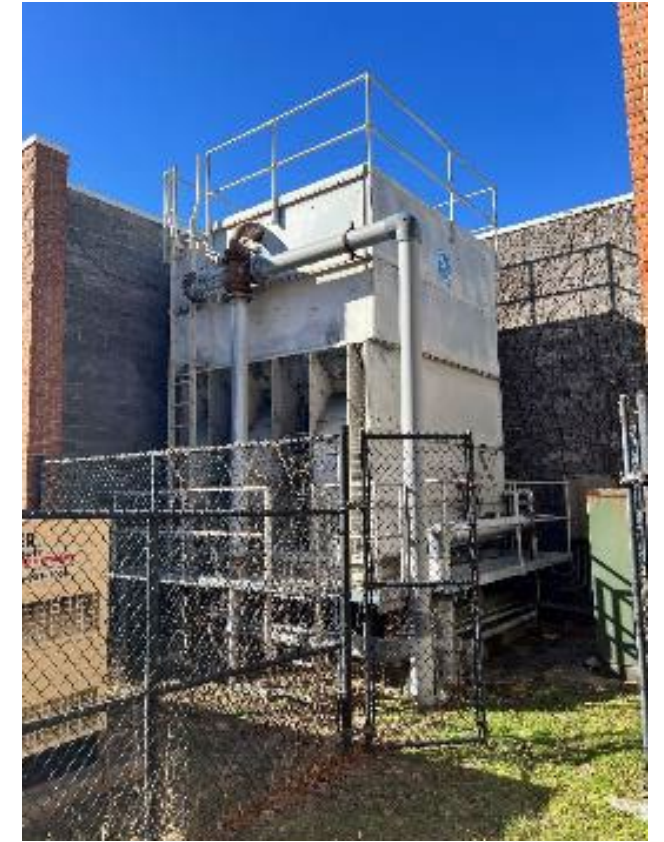
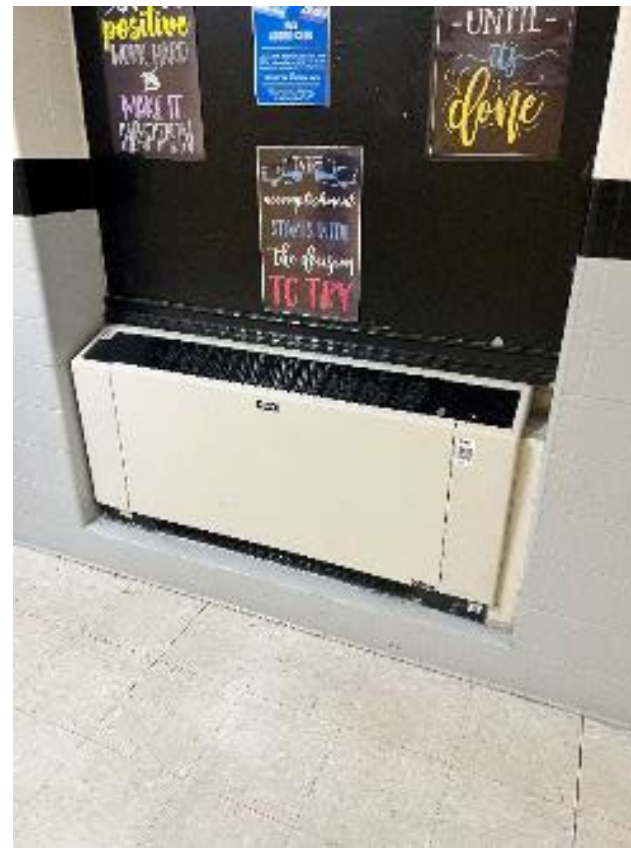
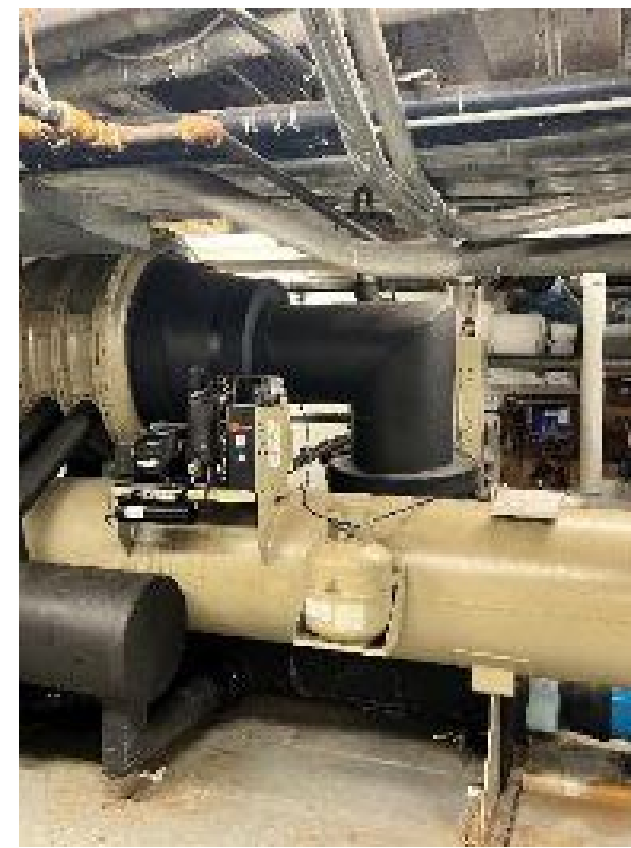
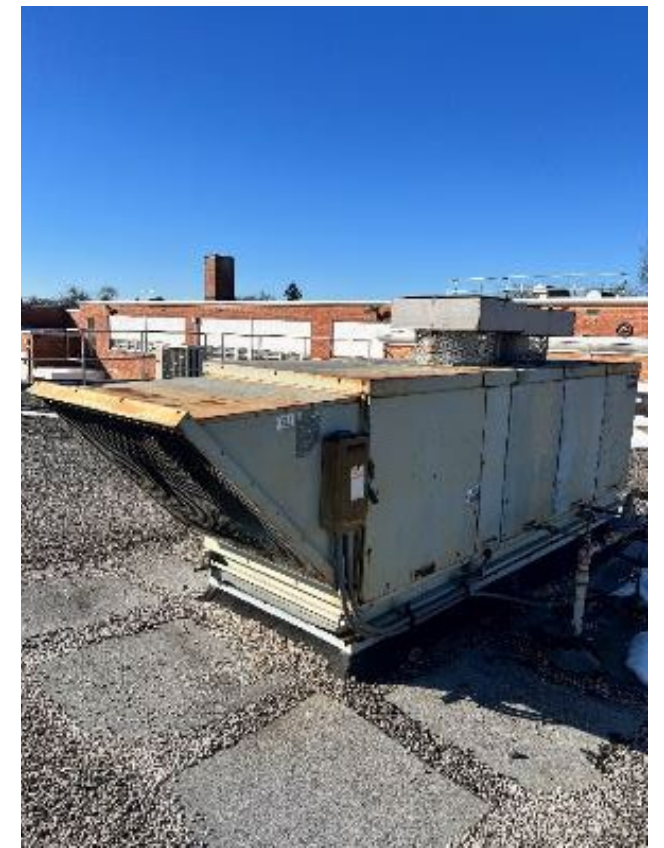
Mechanical Observations

- Central plant equipment (boilers, chiller, cooling tower, and associated pumps) have reached or are approaching their expected useful service life
- Majority of space conditioning and ventilating equipment (air handling units, fan coil units, and unit ventilators) have reached or are approaching their expected useful service life
- The existing 2 -pipe heating/cooling configuration is not ideal for space conditioning and humidity control

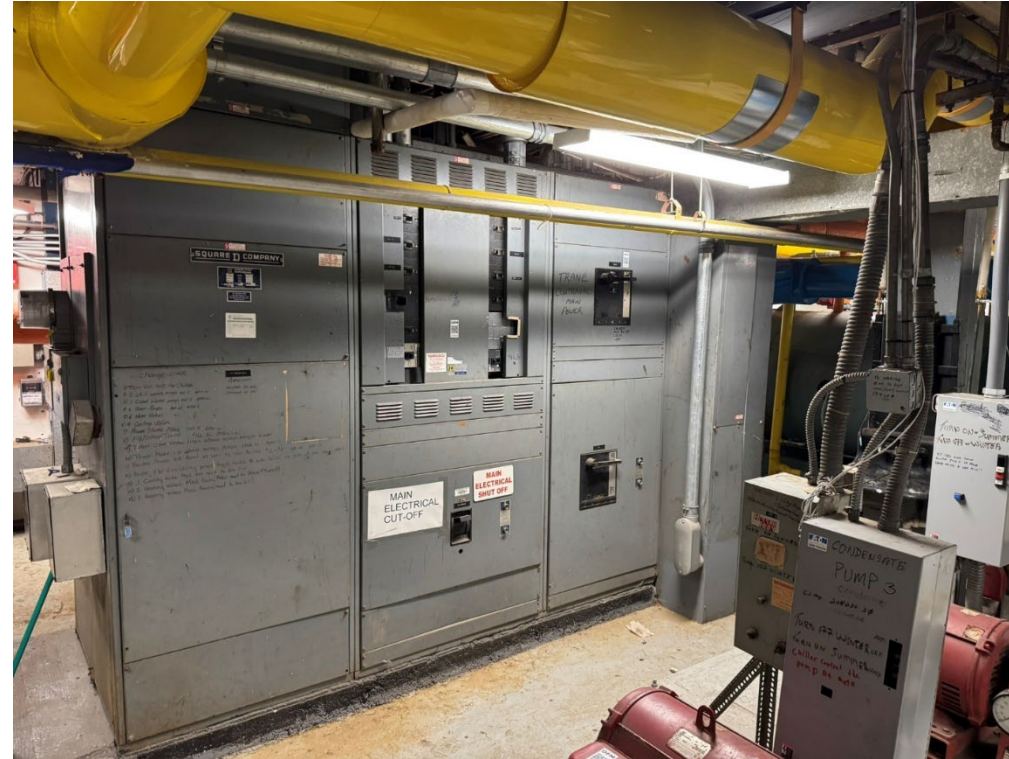
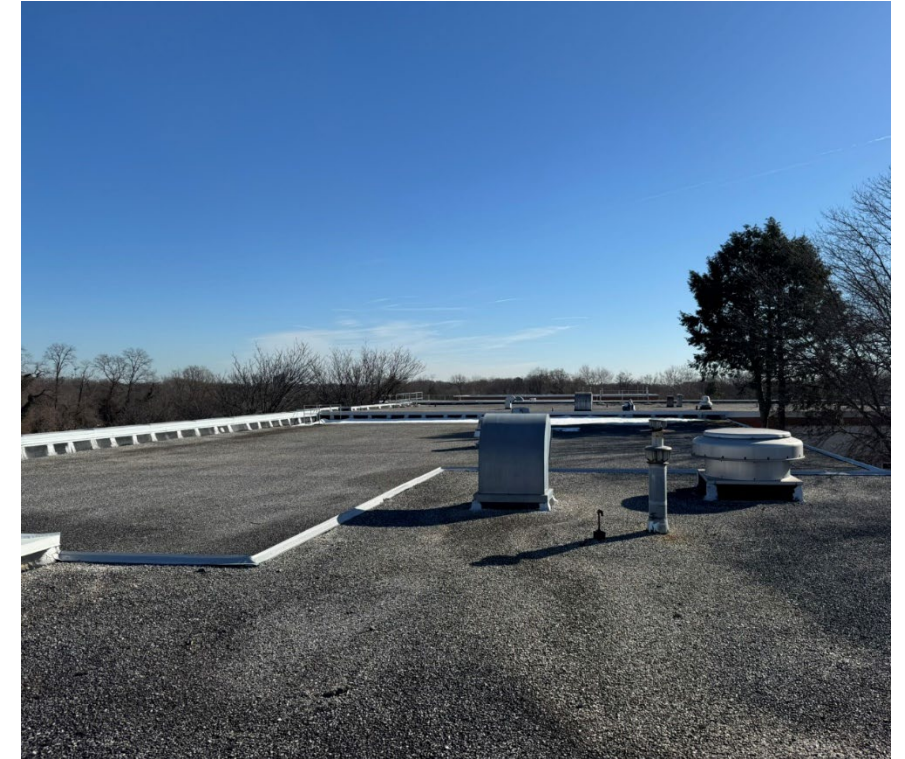
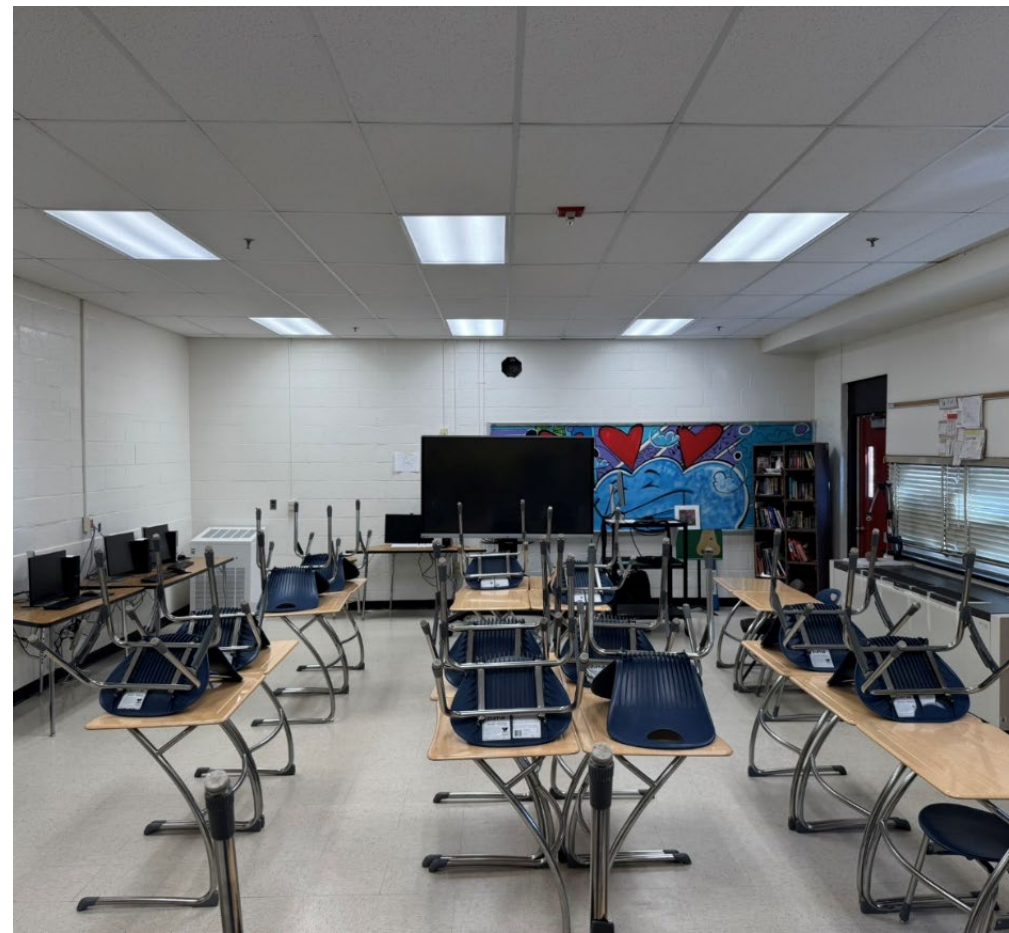
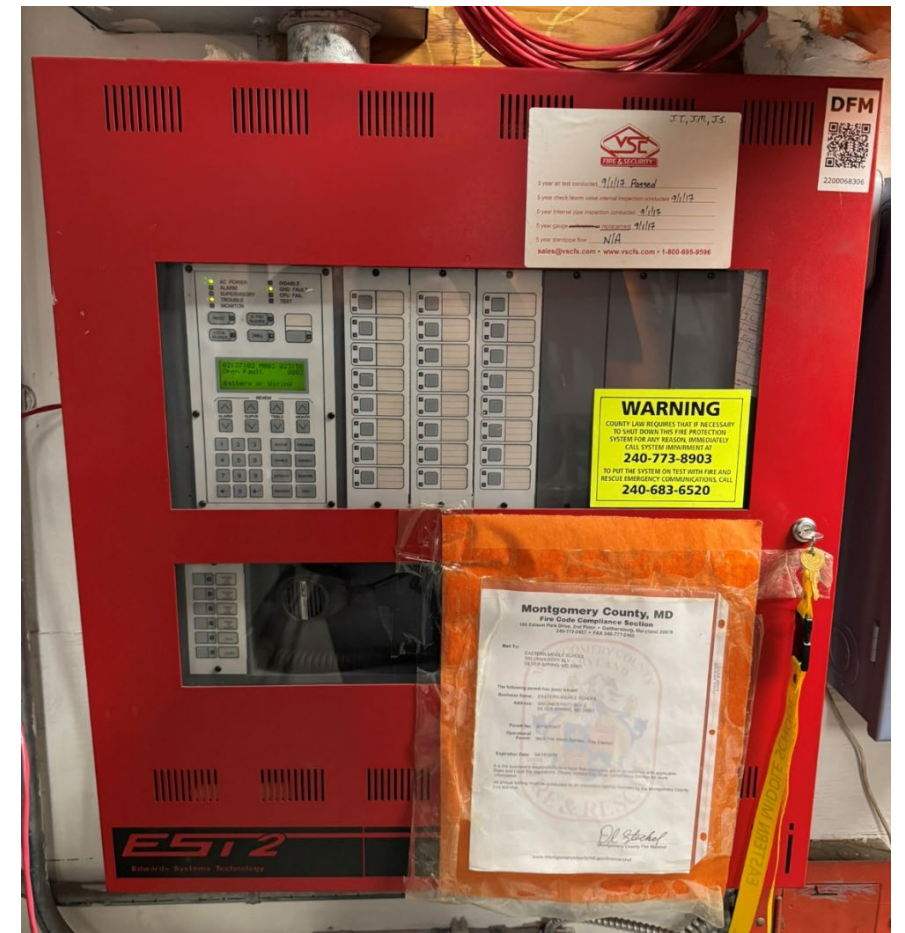
Electrical Observations

- Existing service room conditions leave little room for additional equipment.
- A new main electrical room is recommended for the new main service switchboard.
- The switchboard has minimal space and provisions remaining to add new circuit breakers.
- The existing roof is flat and relatively free of large mechanical equipment; however, the existing structure is not designed to carry the additional load of photovoltaic (PV) panels.
- Interior lighting fixtures typically utilize fluorescent lamps.
- Fire alarm system is outdated. Will require new fire detection and alarm system for the project
