# LEAD-BASED PAINT SCREENING REPORT

**Rock Terrace School  
390 Martins Lane  
Rockville, MD 20850**

*Date of Report: May 20, 2021*

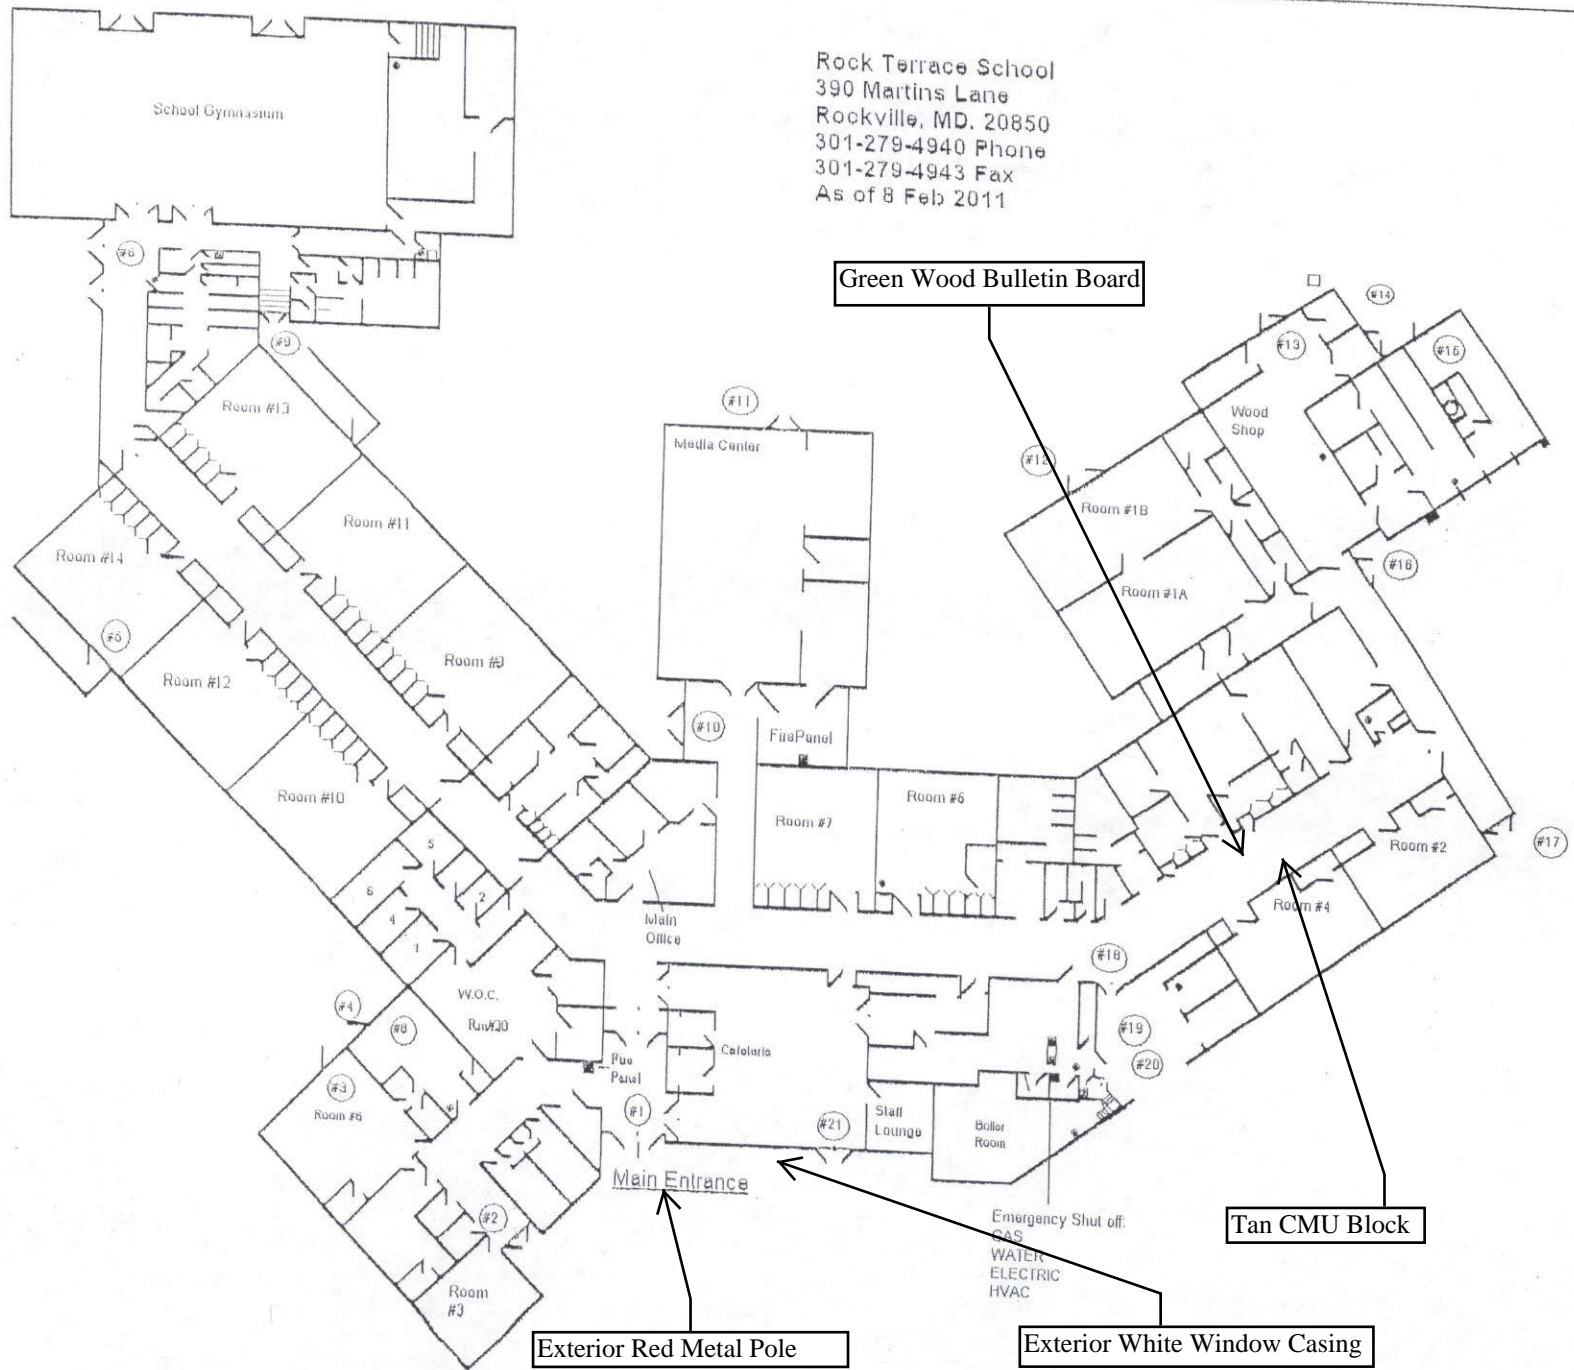
**Attachment B:**  
**Labeled Floor Plan**

Green Wood Bulletin Board

Tan CMU Block

Exterior Red Metal Pole

Exterior White Window Casing

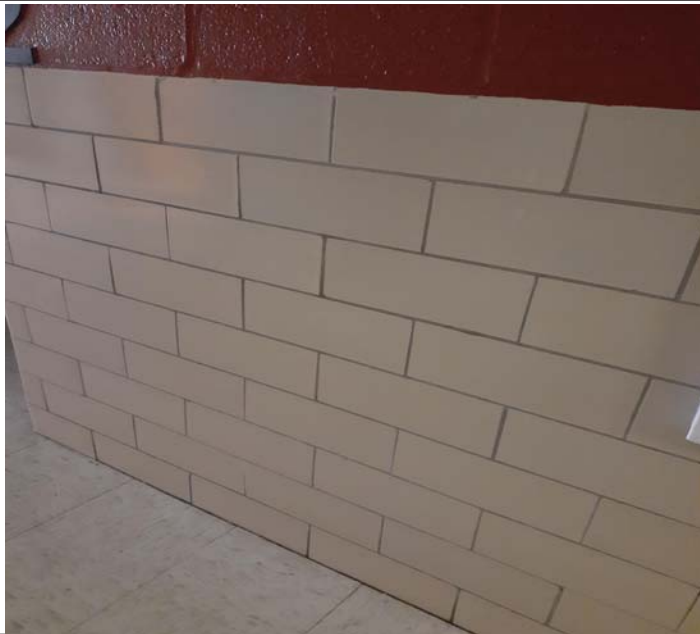
- Tan CMU walls. Lead content detected at 2.8 – 3.7 mg/cm<sup>2</sup> (Photo 1)
- Green wood bulletin boards. Lead content detected at 1.6 – 1.8 mg/cm<sup>2</sup> (Photo 2)

Picture 1: Tan CMU Block

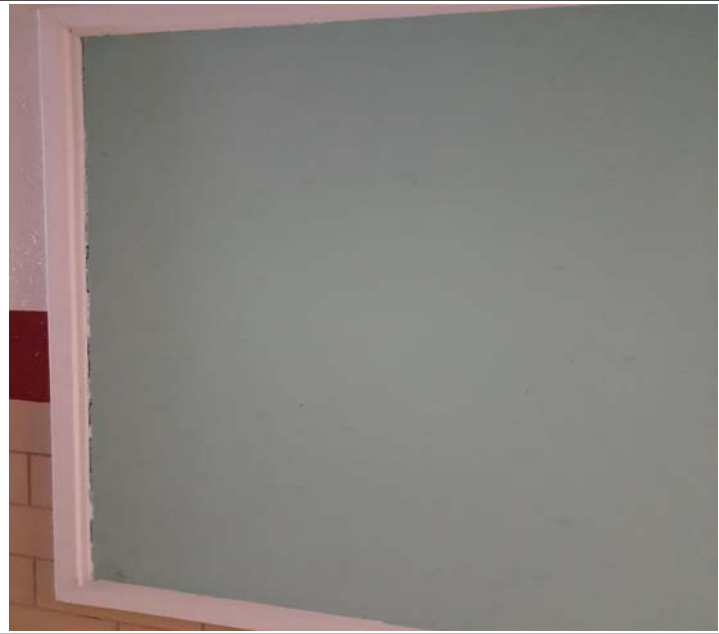
Picture 2: Green Wood Bulletin Board

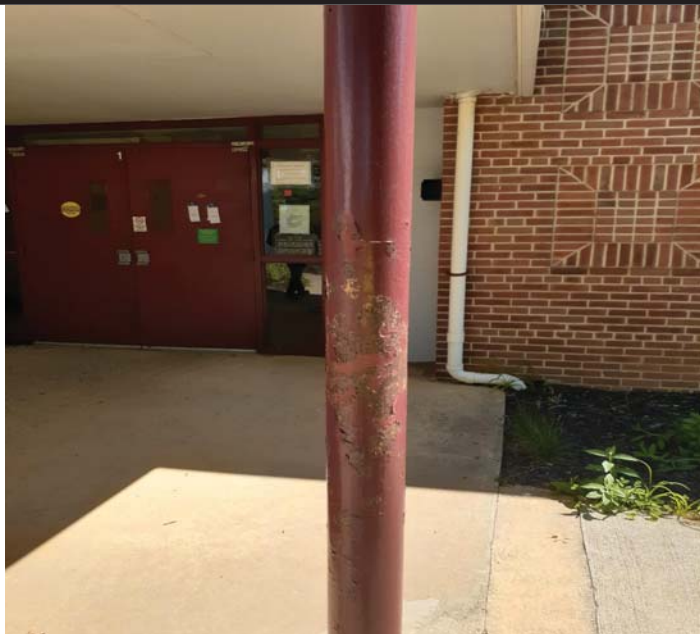
- White metal window components. Lead content detected at 1.4 – 6 mg/cm<sup>2</sup> (Photo 4)
- Red metal pole. Lead content detected at 2.6 mg/cm<sup>2</sup> (Photo 3)

Picture 3: Exterior Red Metal Pole

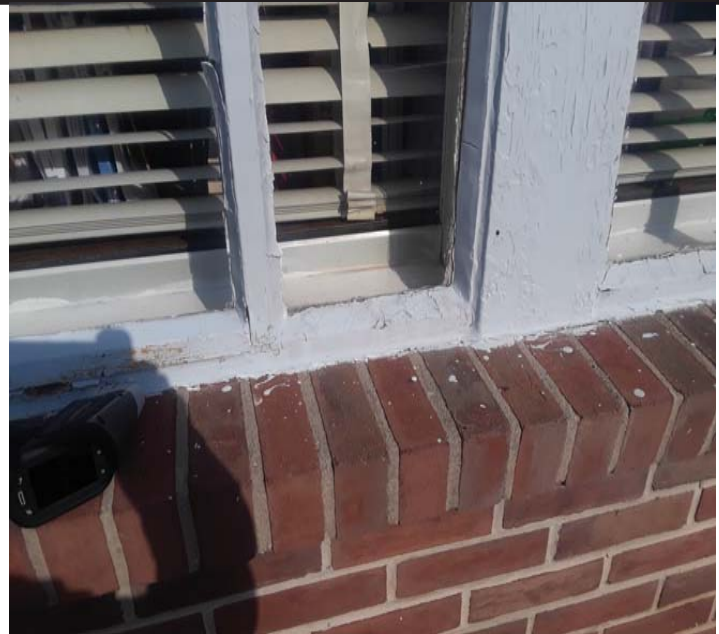
Picture 4: Exterior White Metal Window Casing
