# **CAPTAIN JAMES E. DALY ELEMENTARY SCHOOL**

## **Addition Feasibility Study**

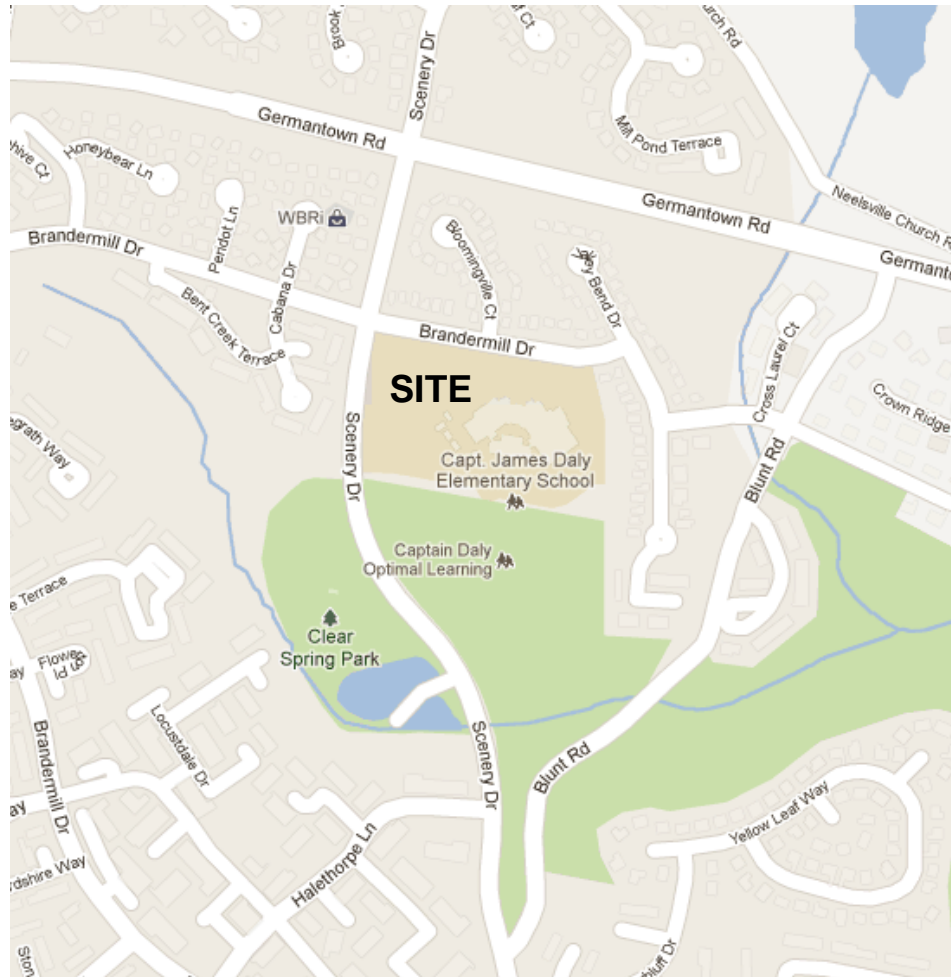
## IV. Existing Conditions (Continued)

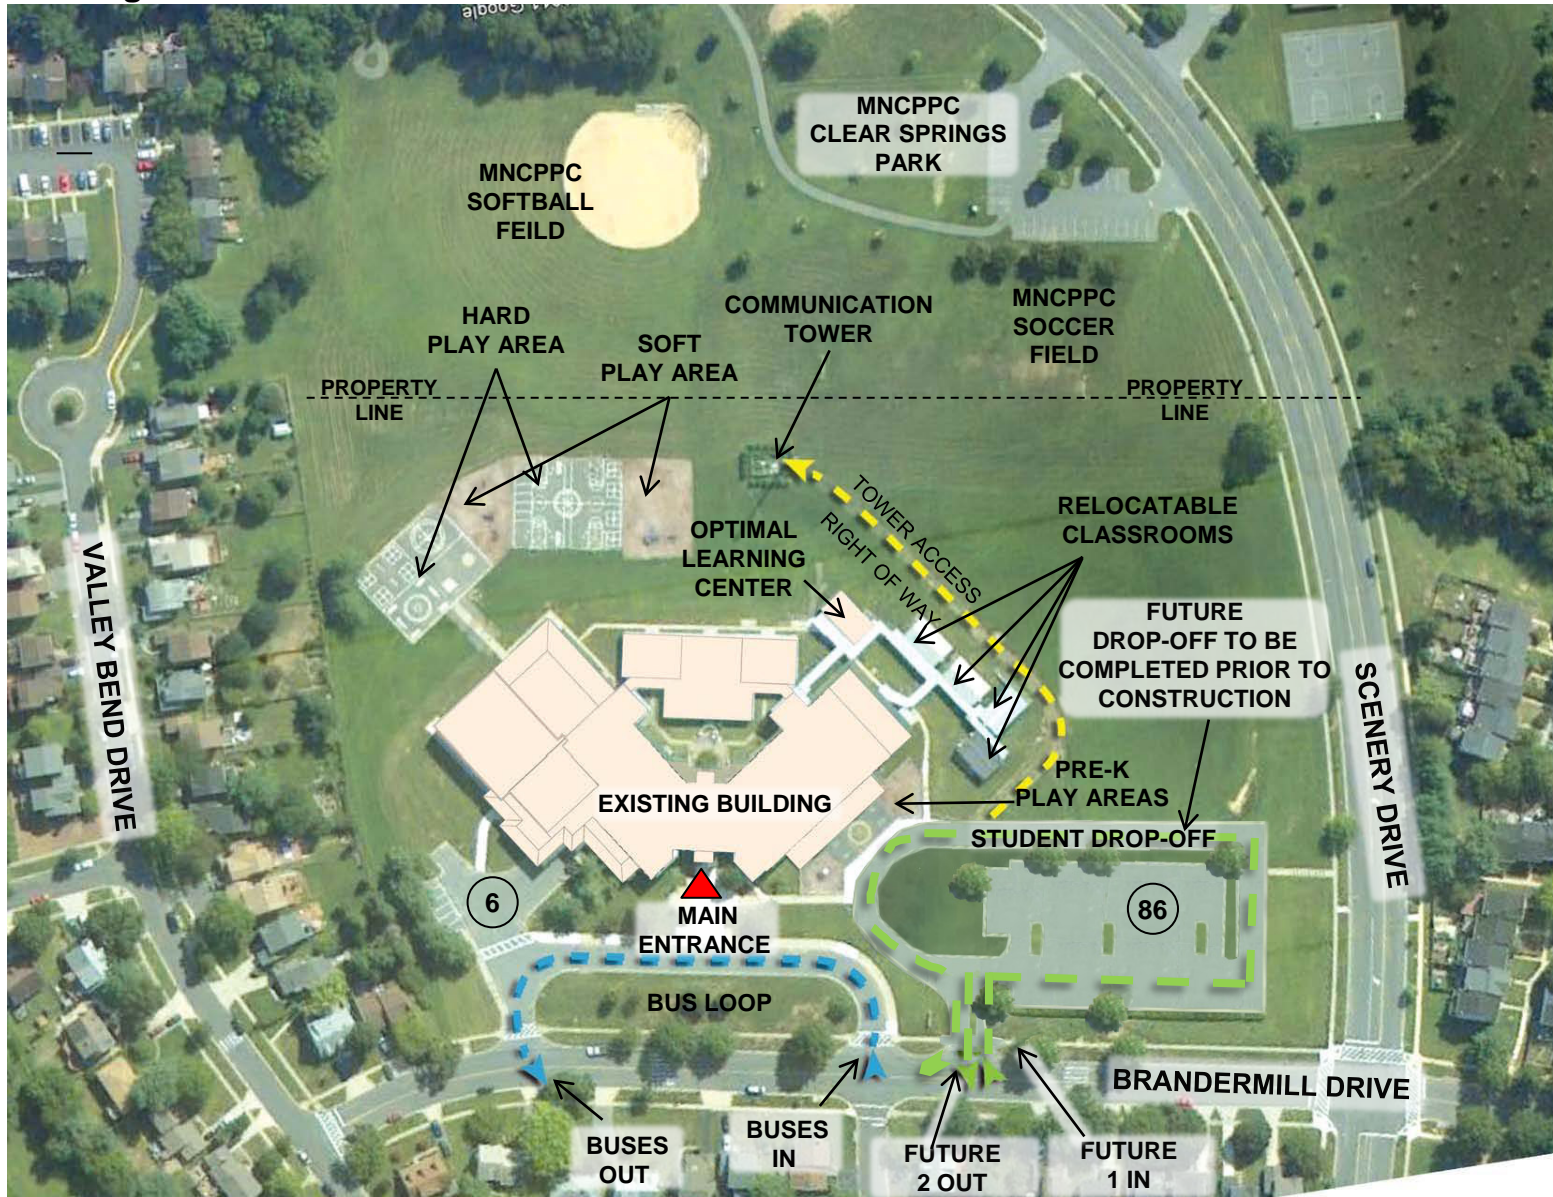
### Existing Site Plan

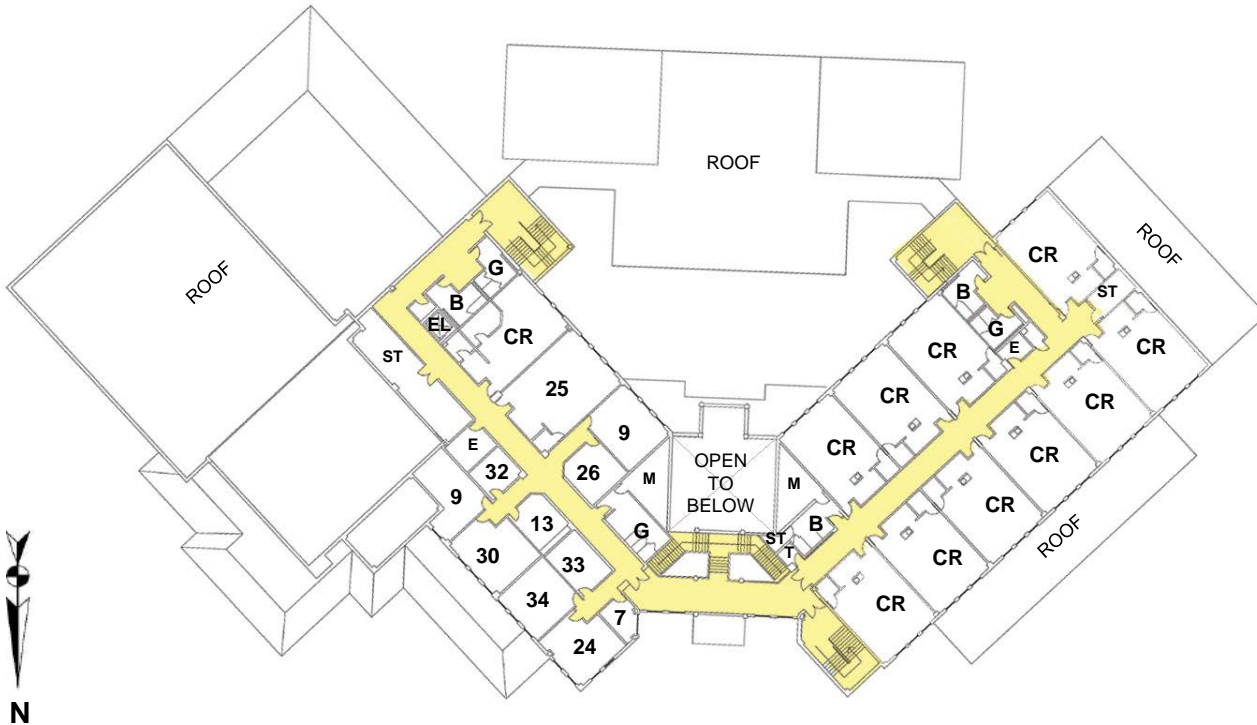
### Existing Second Floor Plan

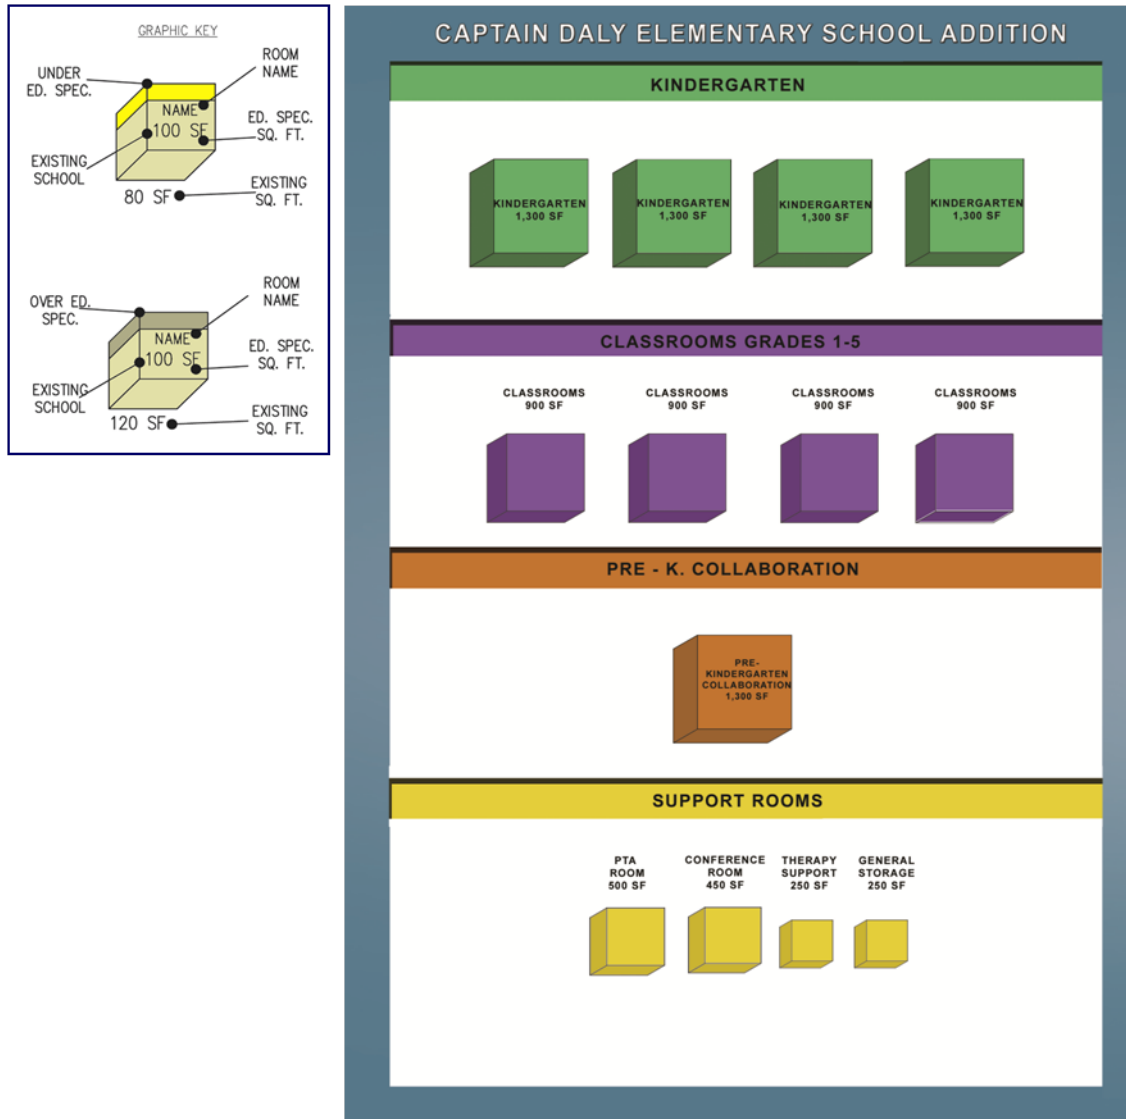
## VIII. Appendix (Continued)

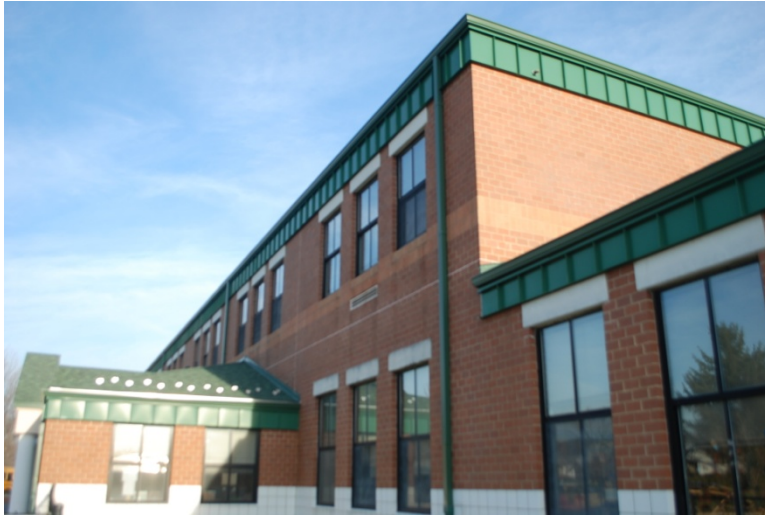
### (B) – Existing Conditions Survey and Photos (Continued)

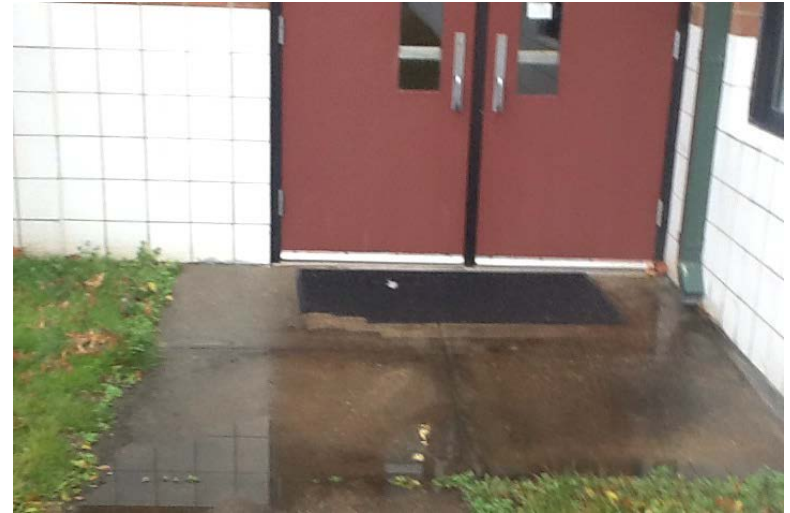
*Roof drain spill onto egress sidewalks create icing hazard.*

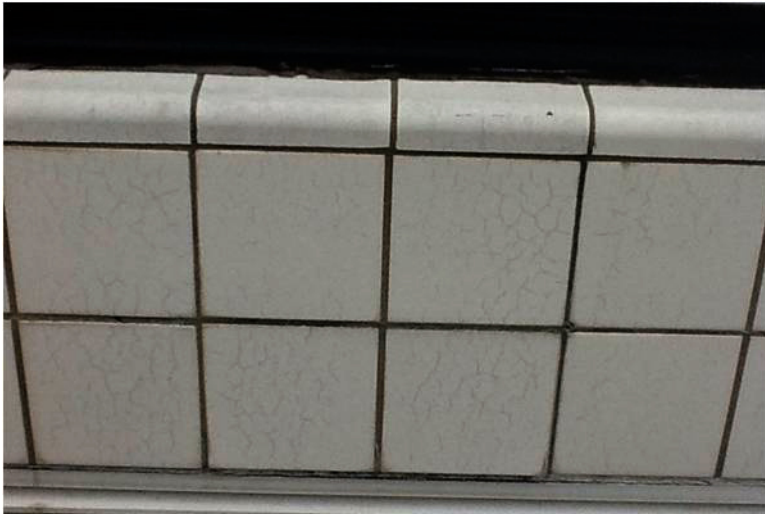
*Crazing glazed blocks.*

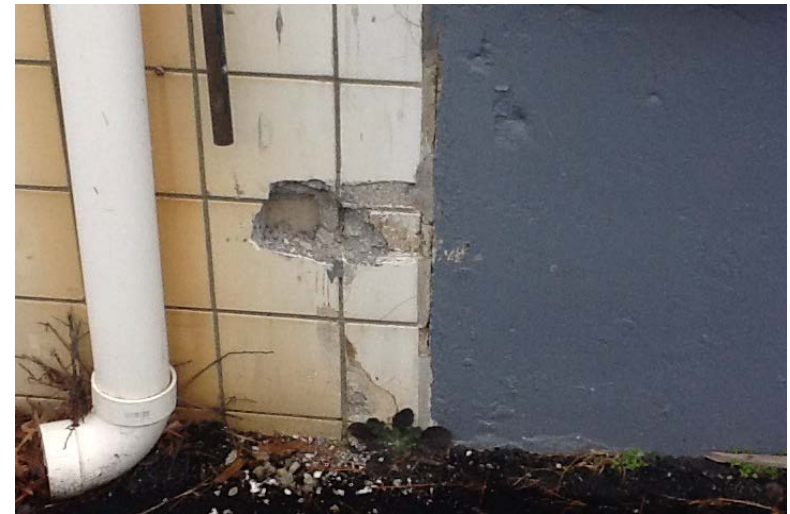
*Minor damages to exterior wall.*

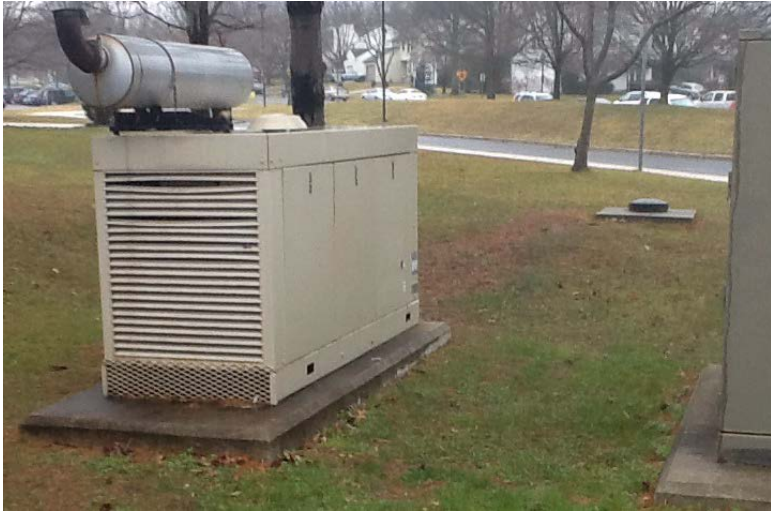
*No screen wall around generator.*

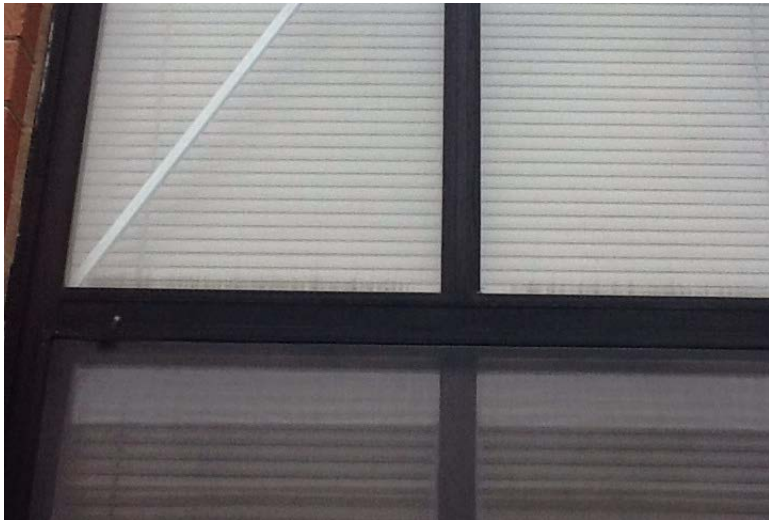
*Window sash failure.*

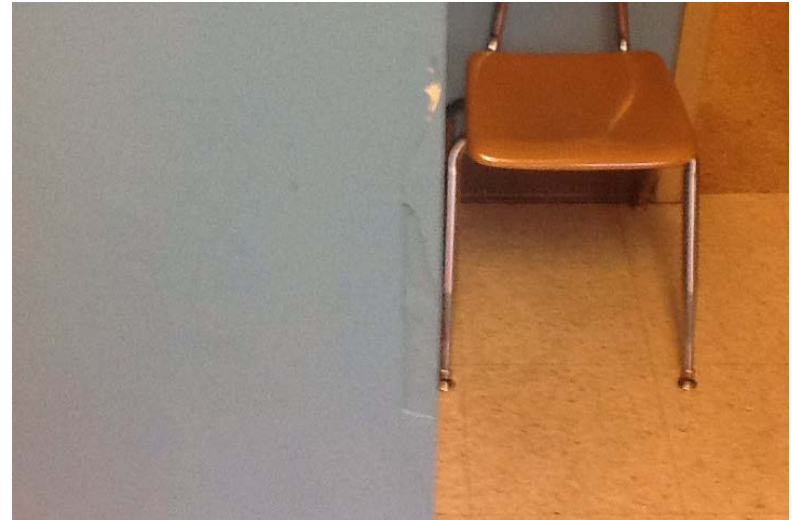
*Minor damages to drywall within corridors.*

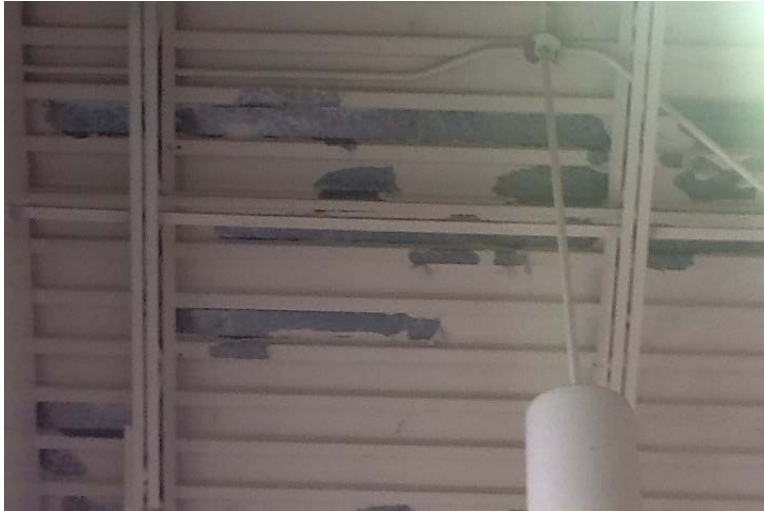
*Vestibule ceiling's paint peeling.*

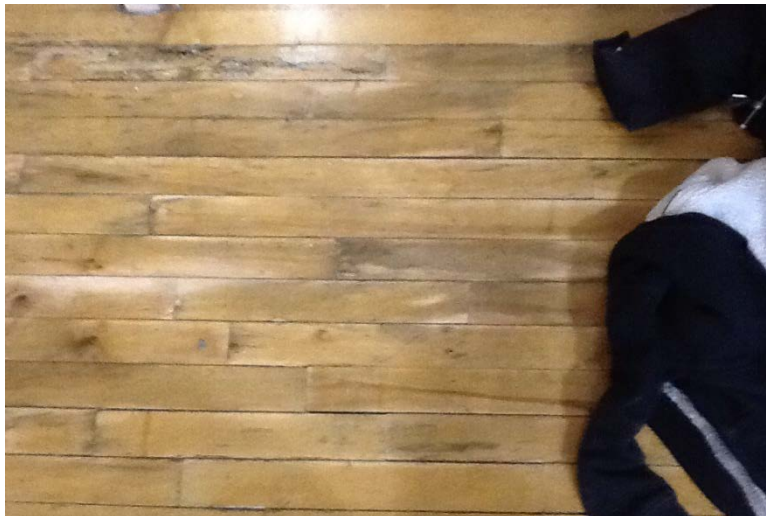
*Water damaged at gymnasium floor.*

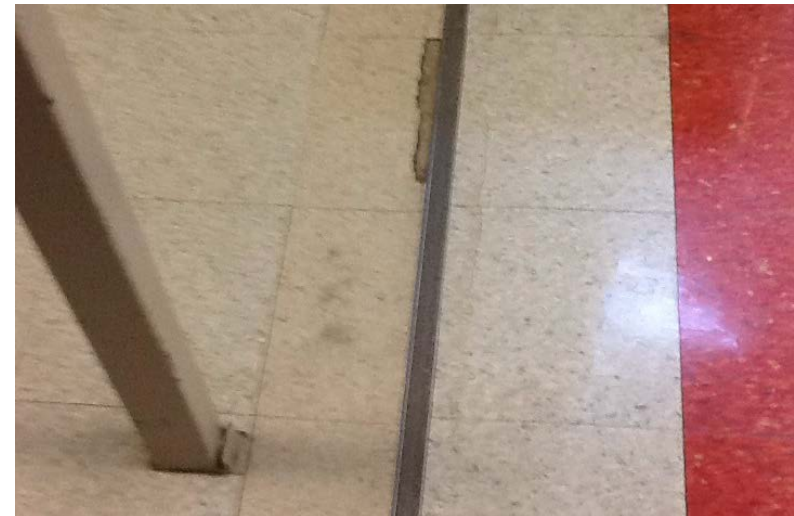
*Floor is cracking and broken from settlement.*

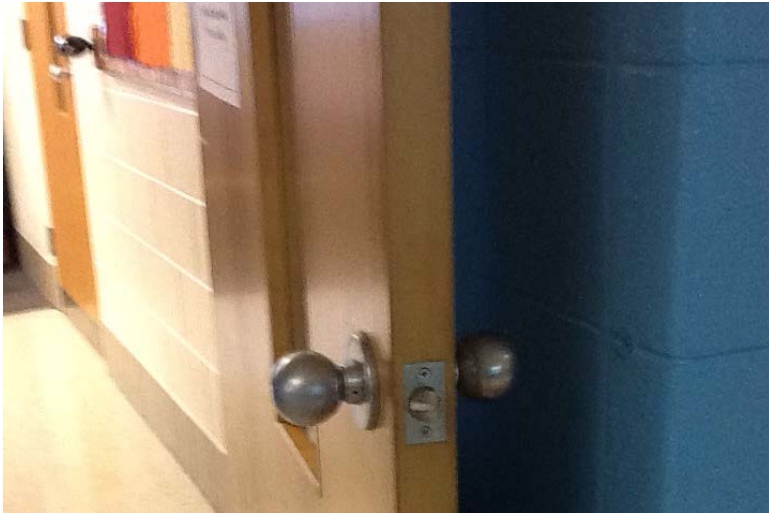
*Door handles not ADA compliant.*
