EASTERN MIDDLE SCHOOL FEASIBILITY STUDY

Community Engagement Meeting No. 1

March 4, 2025, 7:00pm

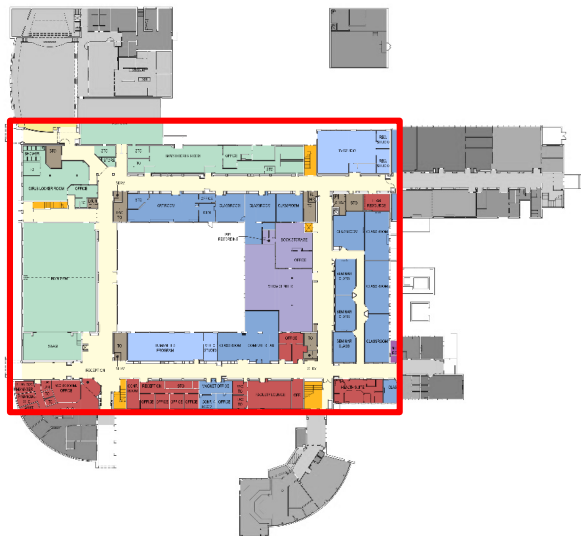
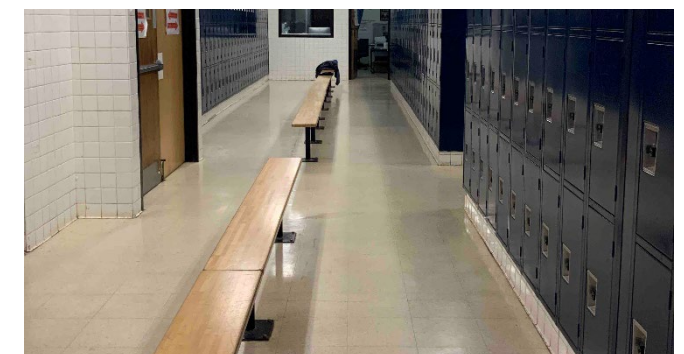
Architectural Observations – 1951 Building

- ADA accessibility issues
- Limited daylighting and exterior views in teaching spaces
- Acoustic concerns
- Inadequate storage and finishes for PE program
- Lack of program space for Magnet program
- Lack of exterior insulation
- Lack of breakout spaces
- Institutional corridors

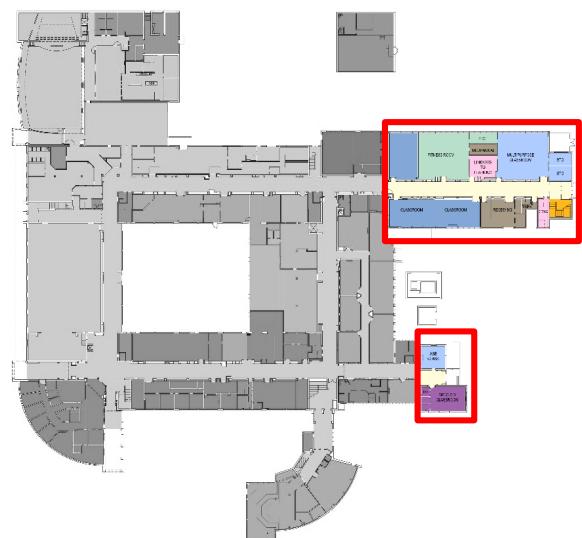
Architectural Observations – 1956 Addition

- Deteriorating classroom finishes
- Visible ceiling leaks
- Signs of water infiltration
- Water ponding on roof

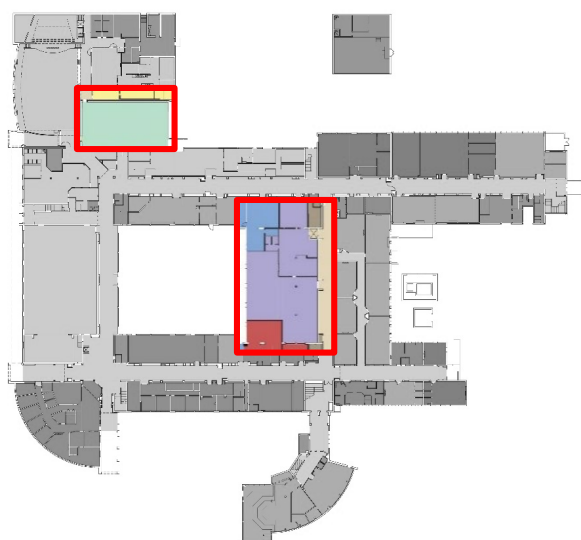
Architectural Observations – 1974 Addition & Renovation

- No daylighting in Aux Gym
- Minimal daylighting in Media Center
- Signs of moisture above ceiling
- Secluded Media Center
- Signs of water infiltration

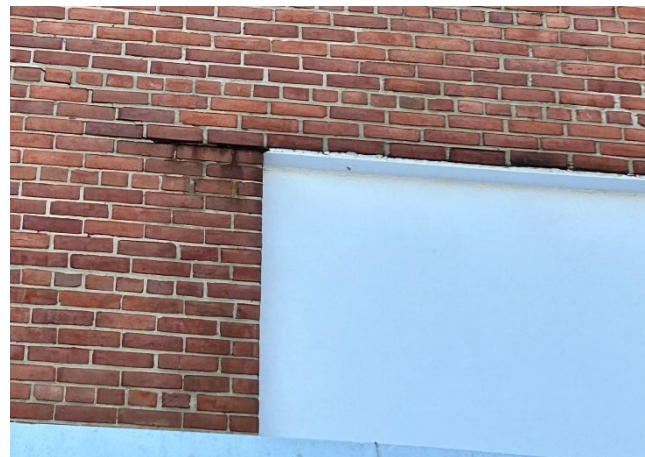
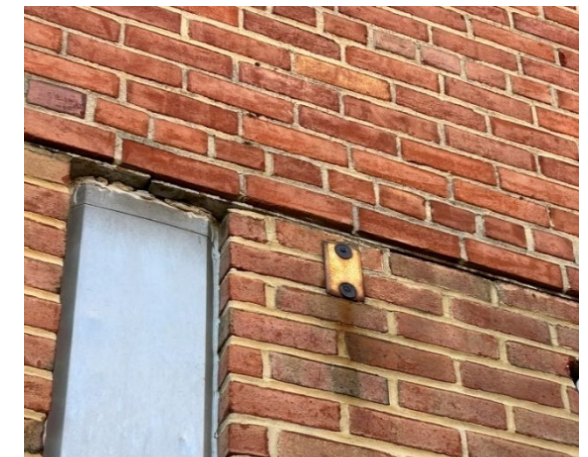
Structural Observations

- Deterioration of the continuous steel bent plate supporting brick
- Stair stepping cracks in brick
- Displacement of brick
- Deterioration of Concrete Areaway
- Significant Displacement and Damage to the exterior sill / masonry wall
- Deterioration of Masonry at Loading Dock

- Evidence of water infiltration along exterior walls
- First floor concrete framing over crawl space inhibits ability to reorganize corridors
- Second floor slab on form deck inhibits ability to reorganize corridors
- Limited data available on foundations of 1951 building
